Carsins Runs I-95 Section 200 Stream Mitigation

PS&E Design Report

Prepared for MDTA

KCI Technologies, Inc. September 2019 KCI Project No. 22145228.47

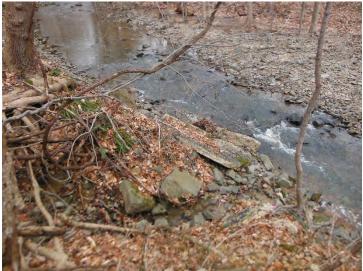
Facing mainstem from top of right bank at upstream confluence of tributary with mainstem.

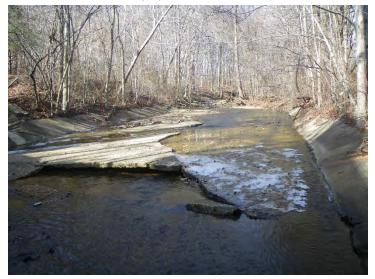
Facing upstream from Sta. 14+44 (invert of upstream end I-95 culvert) showing broken concrete lining to be removed).

The survey indicates presence of more than 4,000 square feet of concrete-lined bed and banks. However, the observed depositional features (i.e. point bar) suggest that the concrete could extend beyond the area surveyed. KCI obtained the December 10, 1963 as-builts for the Northeastern Expressway (File H-X856C.pdf, contract No. NE 106). The plans indicate that Carsins Run was relocated upstream of I-95. The as-builts indicate 185 linear feet of channel restoration and 200 linear feet 'stream bed paving' (width 31 feet). Based on field measurements of observable concrete, the depth is approximately 3 to 5 inches. It is assumed that the streambed paving is the concrete lined portion of channel. Based on the plan dimensions and field observations, an estimated 80 cubic yards of concrete lines the bottom of Carsins Run upstream of I-95 within the limits of the proposed work. The as-builts do not depict cross sections to reflect the side slope or bank portions of the concrete lined channel. The roadside concrete ditches (type I and type II) noted on the plans, are not being addressed as part of this mitigation project. No test pitting is being performed under the design contract. Verifying and computing the extents and quantities of concrete will be the responsibility of the Contractor.

The proposed mitigation approach for the Mainstem is to remove the concrete within the channel and replace with structures that are more natural to provide long term stability and improved habitat conditions.

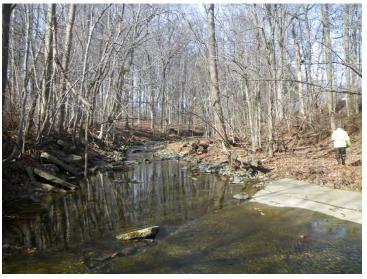
Facing upstream from Sta. 13+90 (proposed location of W-Weir invert)

Just upstream of the culvert under I-95, a W-Weir will be constructed. This will direct flow to the center of each culvert, while also protecting the bed and banks from erosion. Other areas where broken concrete is providing grade control, riffle grade control structures will be used. The proposed structures will provide grade control and bank protection for long-term stability. The W-Weir will improve habitat by creating scour holes and eddies to improve the velocity / depth regime. The riffle grade control structures provide habitat and grade control. The structures are sized to the bankfull elevation as determined through the geomorphic survey.

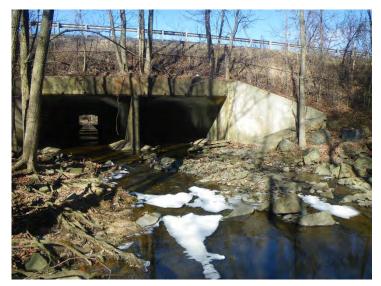
Facing upstream at the downstream face of the I-95 culvert (downstream of I-95), no fish blockages observed.

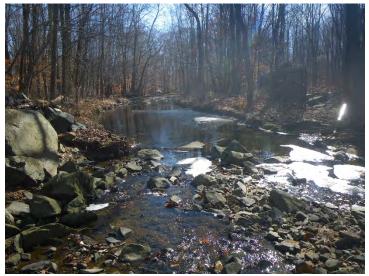
Facing downstream from I-95 culvert.

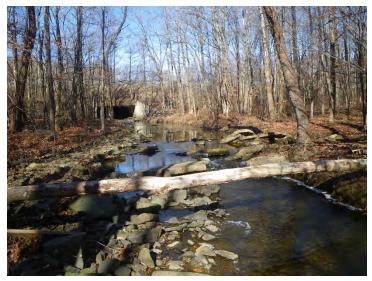
Facing upstream at Carsins Run downstream of I-95 (note broken slabs of concrete).

There are various areas where broken slabs of concrete still exist in the channel (see Appendix A, page 16). A number of unstable inflows discharge into the Carsins Run study Reach: the severely eroded outfall from Randolph Drive on the left, the Tributary *forks* on the right, and the roadside drainage ditches adjacent to I-95 upstream and downstream – left and right.

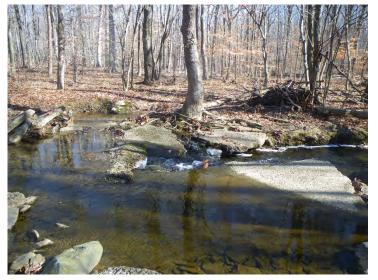
Facing left bank close up of broken concrete slabs.

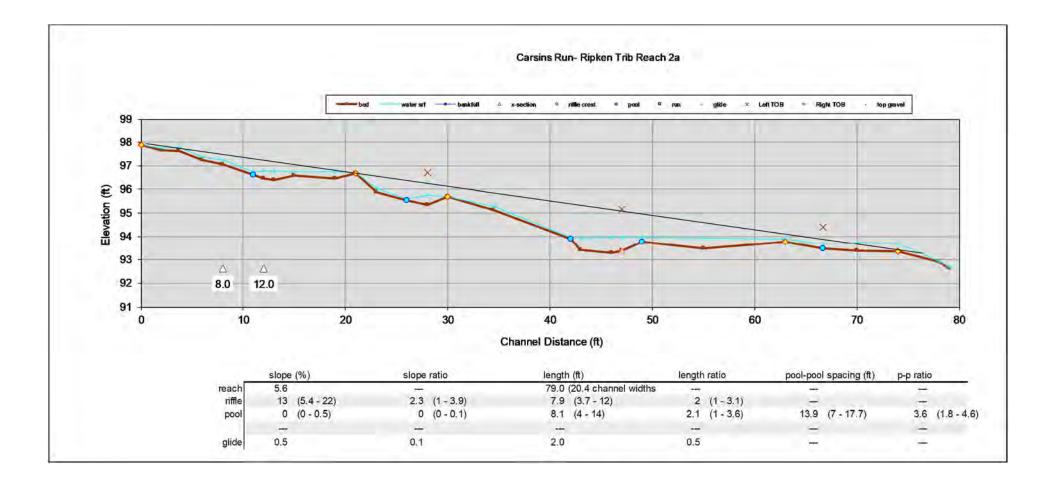
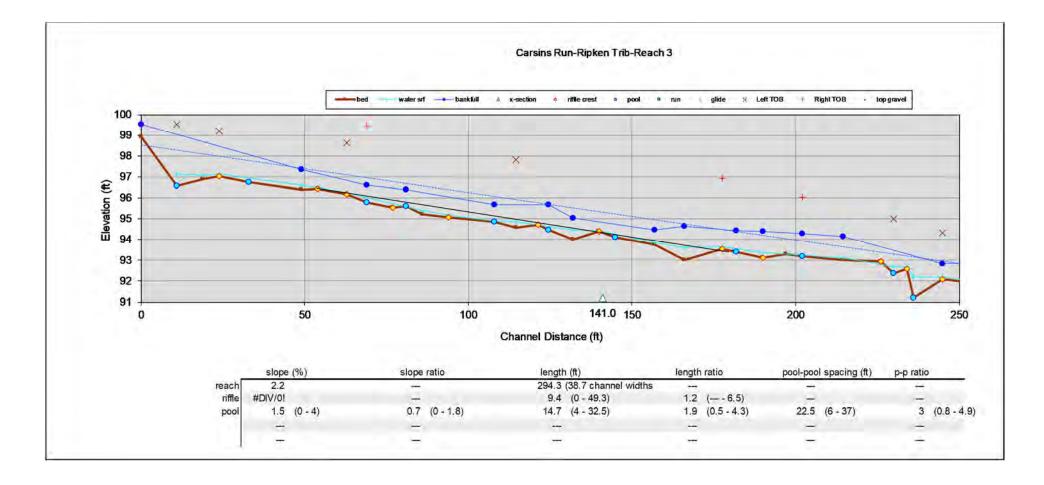
APPENDIX B.2. GEOMORPHIC LONGITUDINAL PROFILES

Note: The existing conditions mainstem longitudinal profile is from field run topography and is included in the plan set.

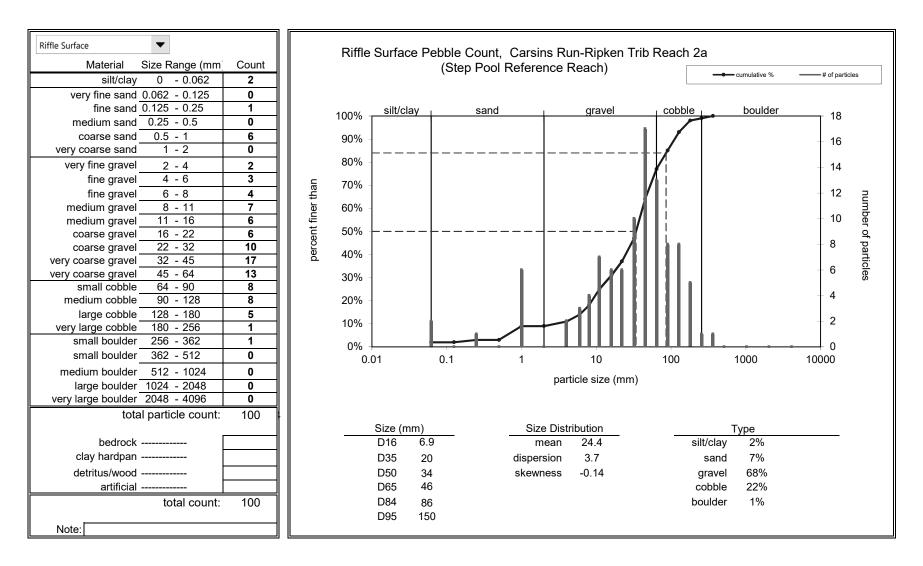
APPENDIX B.3. PEBBLE COUNT / MATERIAL DISTRIBUTION SUMMARY

D100~17 to 19 inches

upstream proposed step pool reach that transitions into Reach 2-no action (stable reach), then to Reach 2b, proposed step pools. The largest particles measured in this reach are less than 19 inch intermediate diameter and were observed to have moss growing on them. This suggests that the small boulders appear to be stationary and withstand the shears and velocities under a range of flows. The downstream end of Reach 2, Reach 2b, shows minor bank erosion and aggradation and will be restored as part of the mitigation work (see Appendix A, page 8).

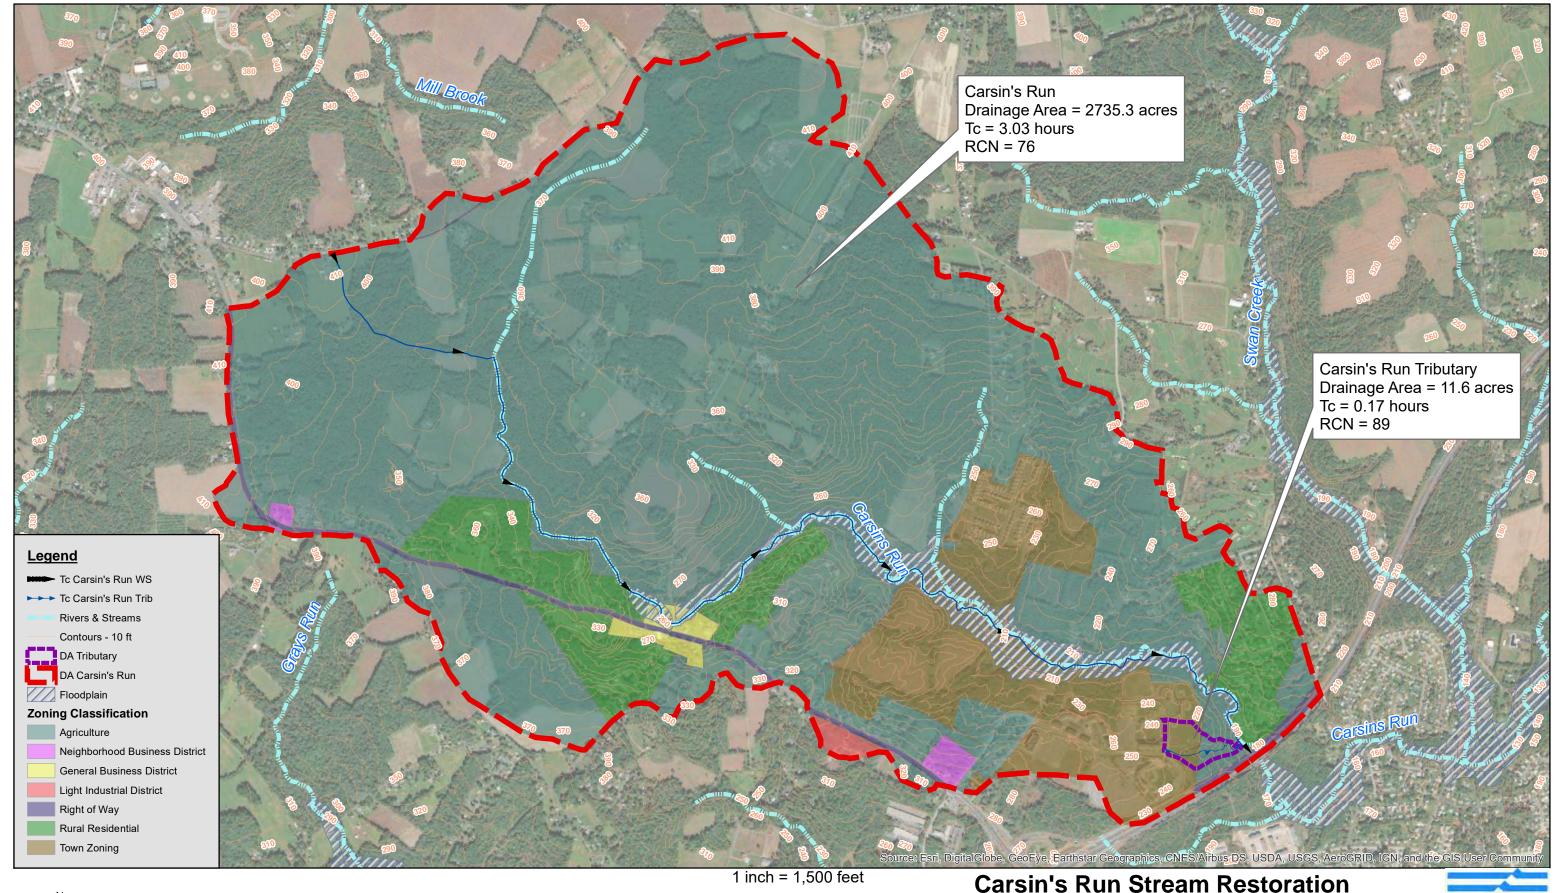
Carsin's Run Stream Restoration Drainage Area Map - Ultimate Condtions Harford County KCI Job No. 22145228.47

Initial Abstraction la =	0.247	in. (Table 5-1)	Use Tc=	0.17	Tt=		
Rainfall Freq. =	1 Year	2 Year	5 Year	10 Year	25 Year	50 Year	100 Year
Rainfall, P (in) =	2.7	3.2	4.2	5.0	6.2	7.3	8.5
la/P =	0.093	0.077	0.060	0.050	0.040	0.034	0.029
Peak csm/in. =	854	854	854	854	854	854	854
Runoff Q (in) =	1.60	2.11	2.96	3.73	4.93	5.99	7.20
Peak Dischg. (CFS)=	24.85	32.66	45.91	57.83	76.34	92.79	111.47

KCI prepared the existing GIS-Hydro hydrologic model developed to represent the field verified drainage boundary of the Carsins Run watershed. A sub-drainage area and associated TR-55 analysis is also included for the Tributary to facilitate the design. The Existing Conditions Hydrologic and Hydraulics Memorandum (see Appendix I.1), documents the procedures and results of the modeling. Discharges were developed for existing and ultimate (zoning) land use conditions for the 1-, 2-, 10-, and 100-year storm events. Tables 1 and 2 summarize discharges for the Tributary and Mainstem. While the Tributary drainage area is zoned for additional development, which results in significantly increased discharges, the presence of the Ripken Stadium deems the ultimate build out scenario unlikely.
