MEMORANDUM

Subject: I-95 ETL Northbound Extension – ITS and Sign Installation Study Areas

**APPENDIX B – WETLAND DELINEATION AND FOREST
CHARACTERIZATION/TREE SURVEY MAPS**

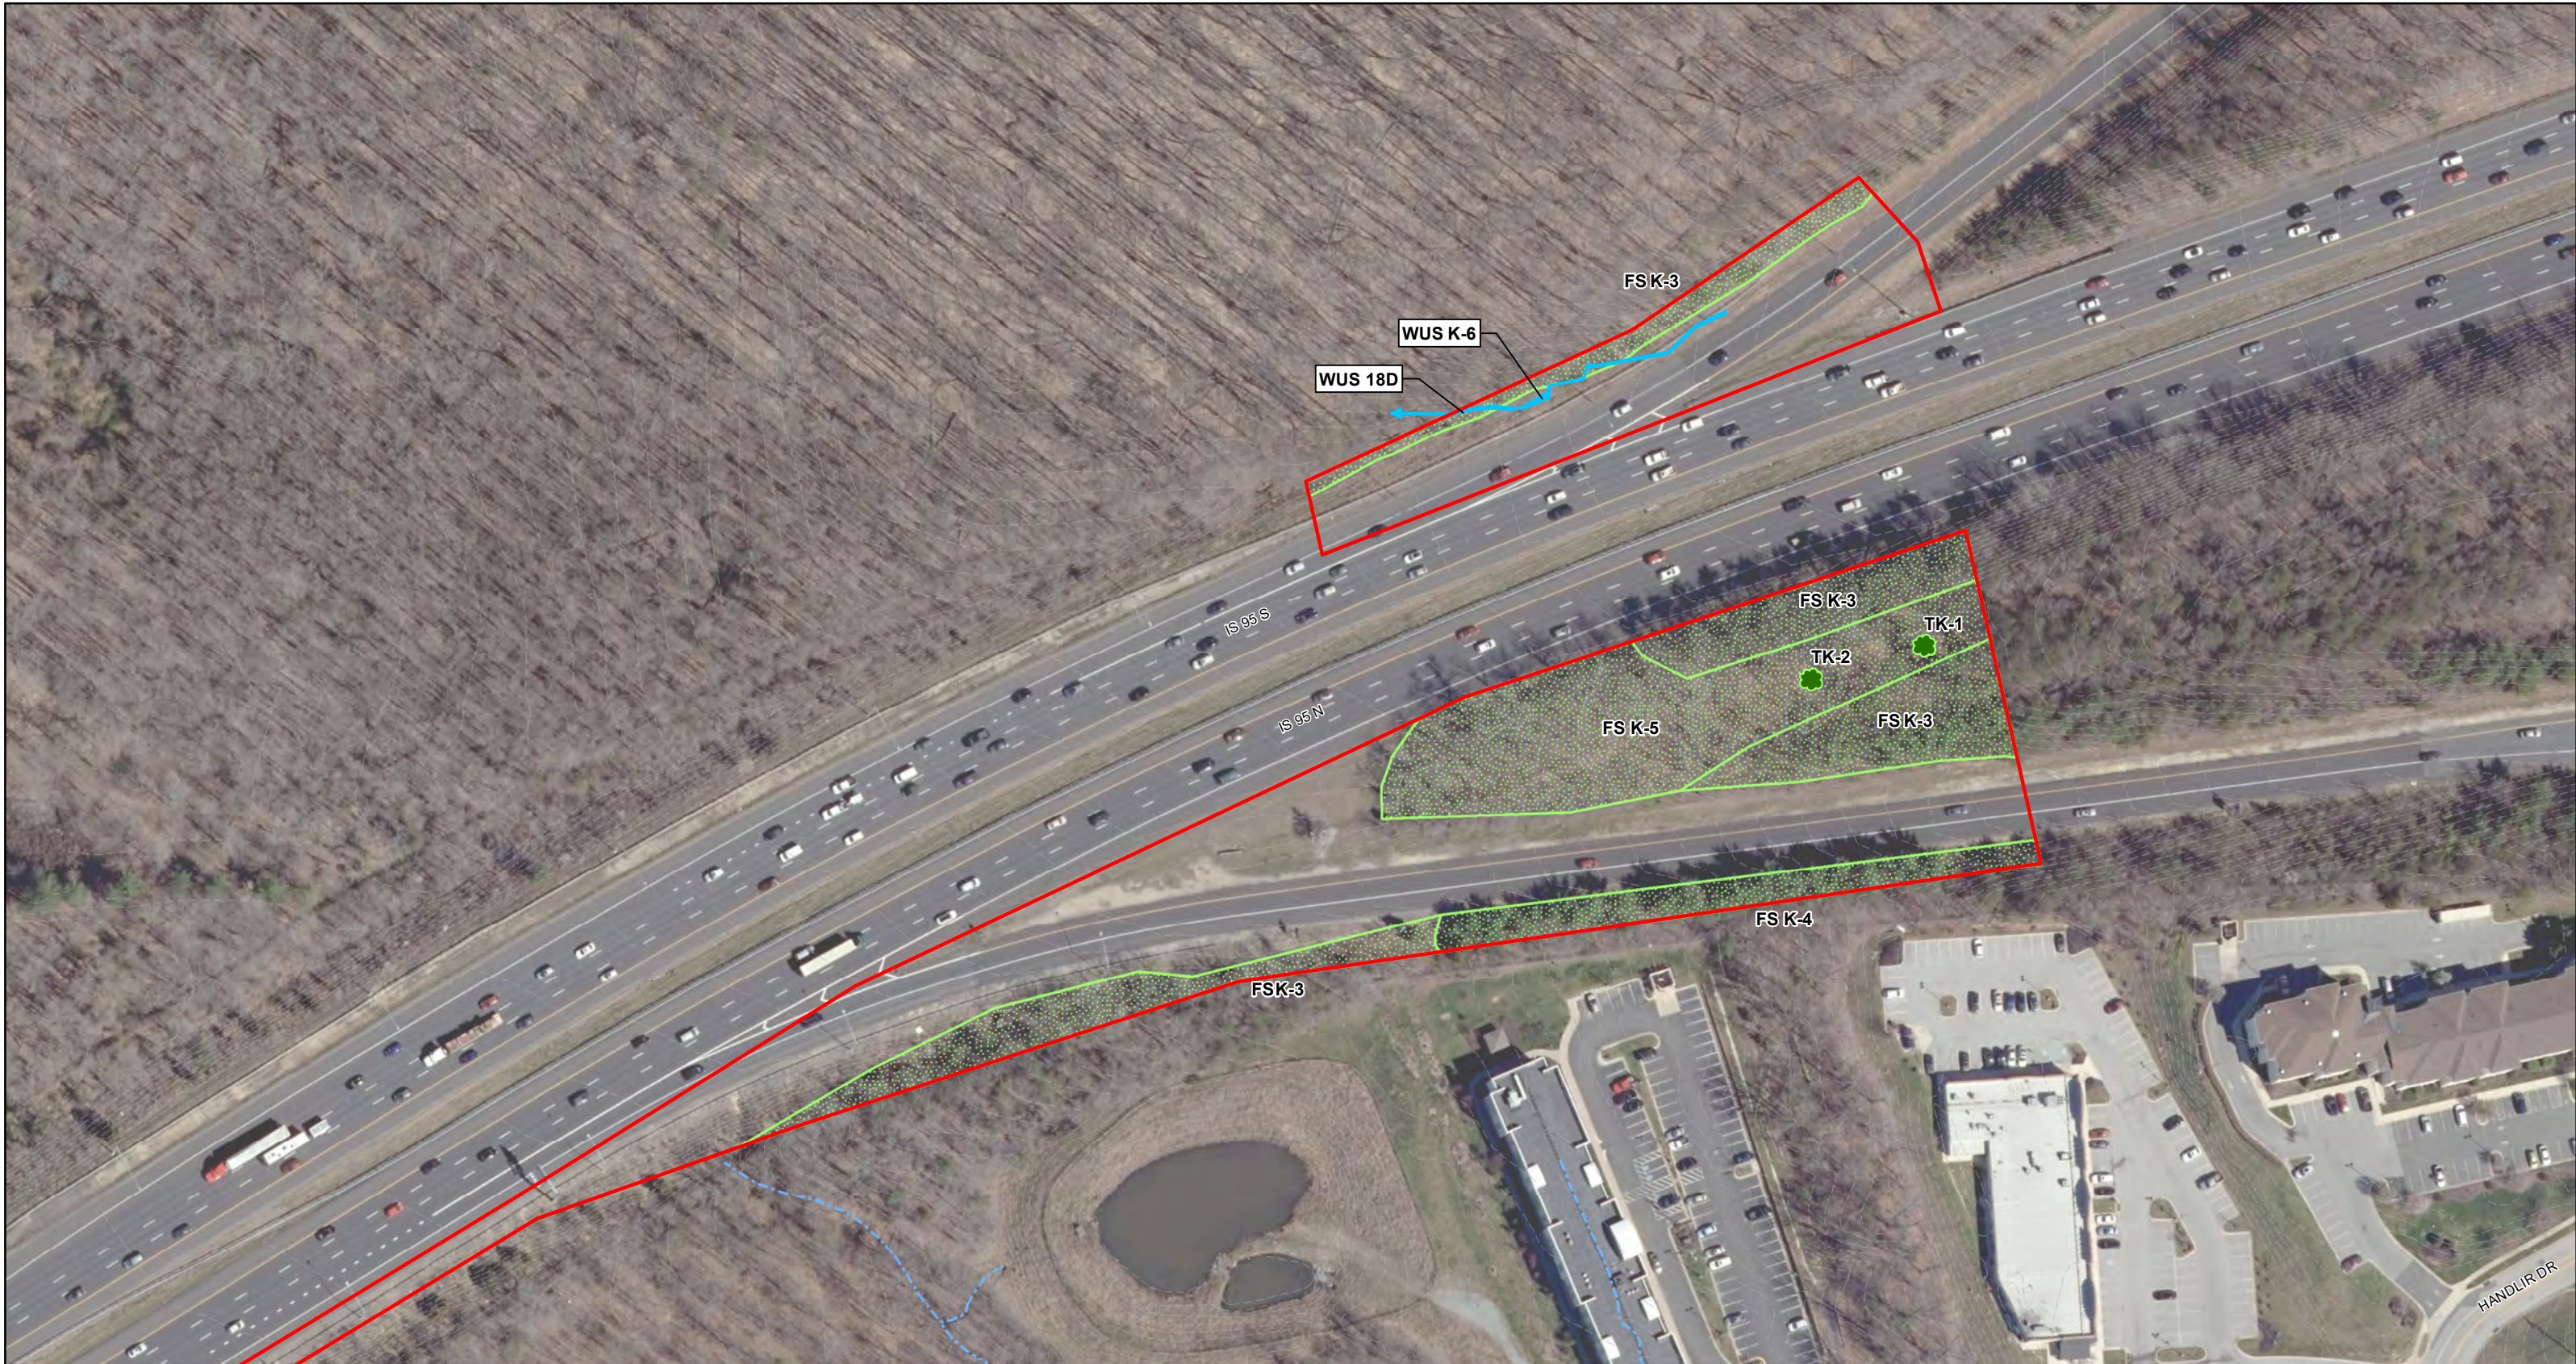
SHEET 1 OF 11
Harford County, MD
July 2019

WUS K-6 is an intermittent stream that originates as a roadside ditch north of I-95 (**Appendix B, Sheet 1**). The stream flows southwest and discharges into WUS 18D. The stream channel is approximately 3 feet wide with banks approximately 1 foot high; at the time of the delineation, flow within the channel varied between 1 and 3 inches deep. The substrate consists of gravel, sand, and silt. The stream is low quality within the study area because it is highly manipulated and receives extensive pollution from road runoff. WUS K-6 was previously delineated as a wetland (WET 18D) in 2006 and is included in the *Wetland Identification and Delineation Report for Section 200: I-95, North of MD 43 to North of MD 22* (JMT 2006). This system is currently classified as a stream rather than a wetland due to the presence of channel characteristics, including disturbed vegetation, disturbed leaf litter, and sediment deposition, and flowing water during the

WUS 18D is an intermittent stream that flows from a culvert under I-95 (**Appendix B, Sheet 1**). The stream flows west and eventually discharges into James Run outside of the study area. The stream channel is approximately 2 feet wide with banks approximately 3 feet high; at the time of the delineation, flow within the channel varied between 1 and 2 inches deep. The substrate consists of gravel, sand, and rip-rap. The stream is low quality within the study area because it is highly manipulated and receives extensive pollution from road runoff. WUS 18D was previously delineated and included in the *Wetland Identification and Delineation Report for Section 200: I-95, North of MD 43 to North of MD 22* (JMT 2006).

Forest Stand K-3 is located along I-95 near the MD 543 interchange (**Appendix B, Sheet 1**). FS K-3 is a deciduous/coniferous, early-successional forest. Dominant canopy species in this stand include sweetgum and Virginia pine (*Pinus virginiana*). Dominant species are predominantly in the 1- to 15-inch DBH size class and 3- to 9-inch DBH size class, with a canopy closure estimated at approximately 70 percent. The co-dominant canopy species include black locust (*Robinia pseudoacacia*). The area of the forest stand within the study area is approximately 1.01 acre. FS K-3 continues beyond the study area limits.

Forest Stand K-4 is located along the exit ramp from I-95 northbound onto MD 543 (**Appendix B, Sheet 1**). FS K-4 is a deciduous/coniferous, early-mid successional forest. Dominant canopy species in this stand include sweetgum and eastern white pine (*Pinus strobus*). Dominant species are predominantly in the 5- to 14-inch DBH size class and 1- to 4-inch DBH size class, with a canopy closure estimated at approximately 95 percent. There are no co-dominant canopy species. The area of the forest stand within the study area is approximately 0.26 acre. FS K-4 continues east beyond the study area limits.

Forest Stand K-5 is located north of the ramp from of I-95 northbound to MD 543 (**Appendix B, Sheet 1**). FS K-5 is a deciduous, mid-late successional forest. Dominant canopy species in this stand include northern red oak (*Quercus rubra*), white oak (*Quercus alba*), pin oak (*Quercus palustris*), and southern red oak (*Quercus falcata*). Dominant species are predominantly in the 2- to 26-inch DBH size class, 16- to 39-inch DBH class, 5- to 16-inch DBH class, and 12- to 26-inch DBH size class, with a canopy closure estimated at approximately 70 percent. The co-dominant canopy species include American beech (*Fagus grandifolia*), sweetgum, and black tupelo (*Nyssa sylvatica*). The area of the forest stand within the study area is approximately 0.86 acre. FS K-5 continues northeast beyond the study area limits.

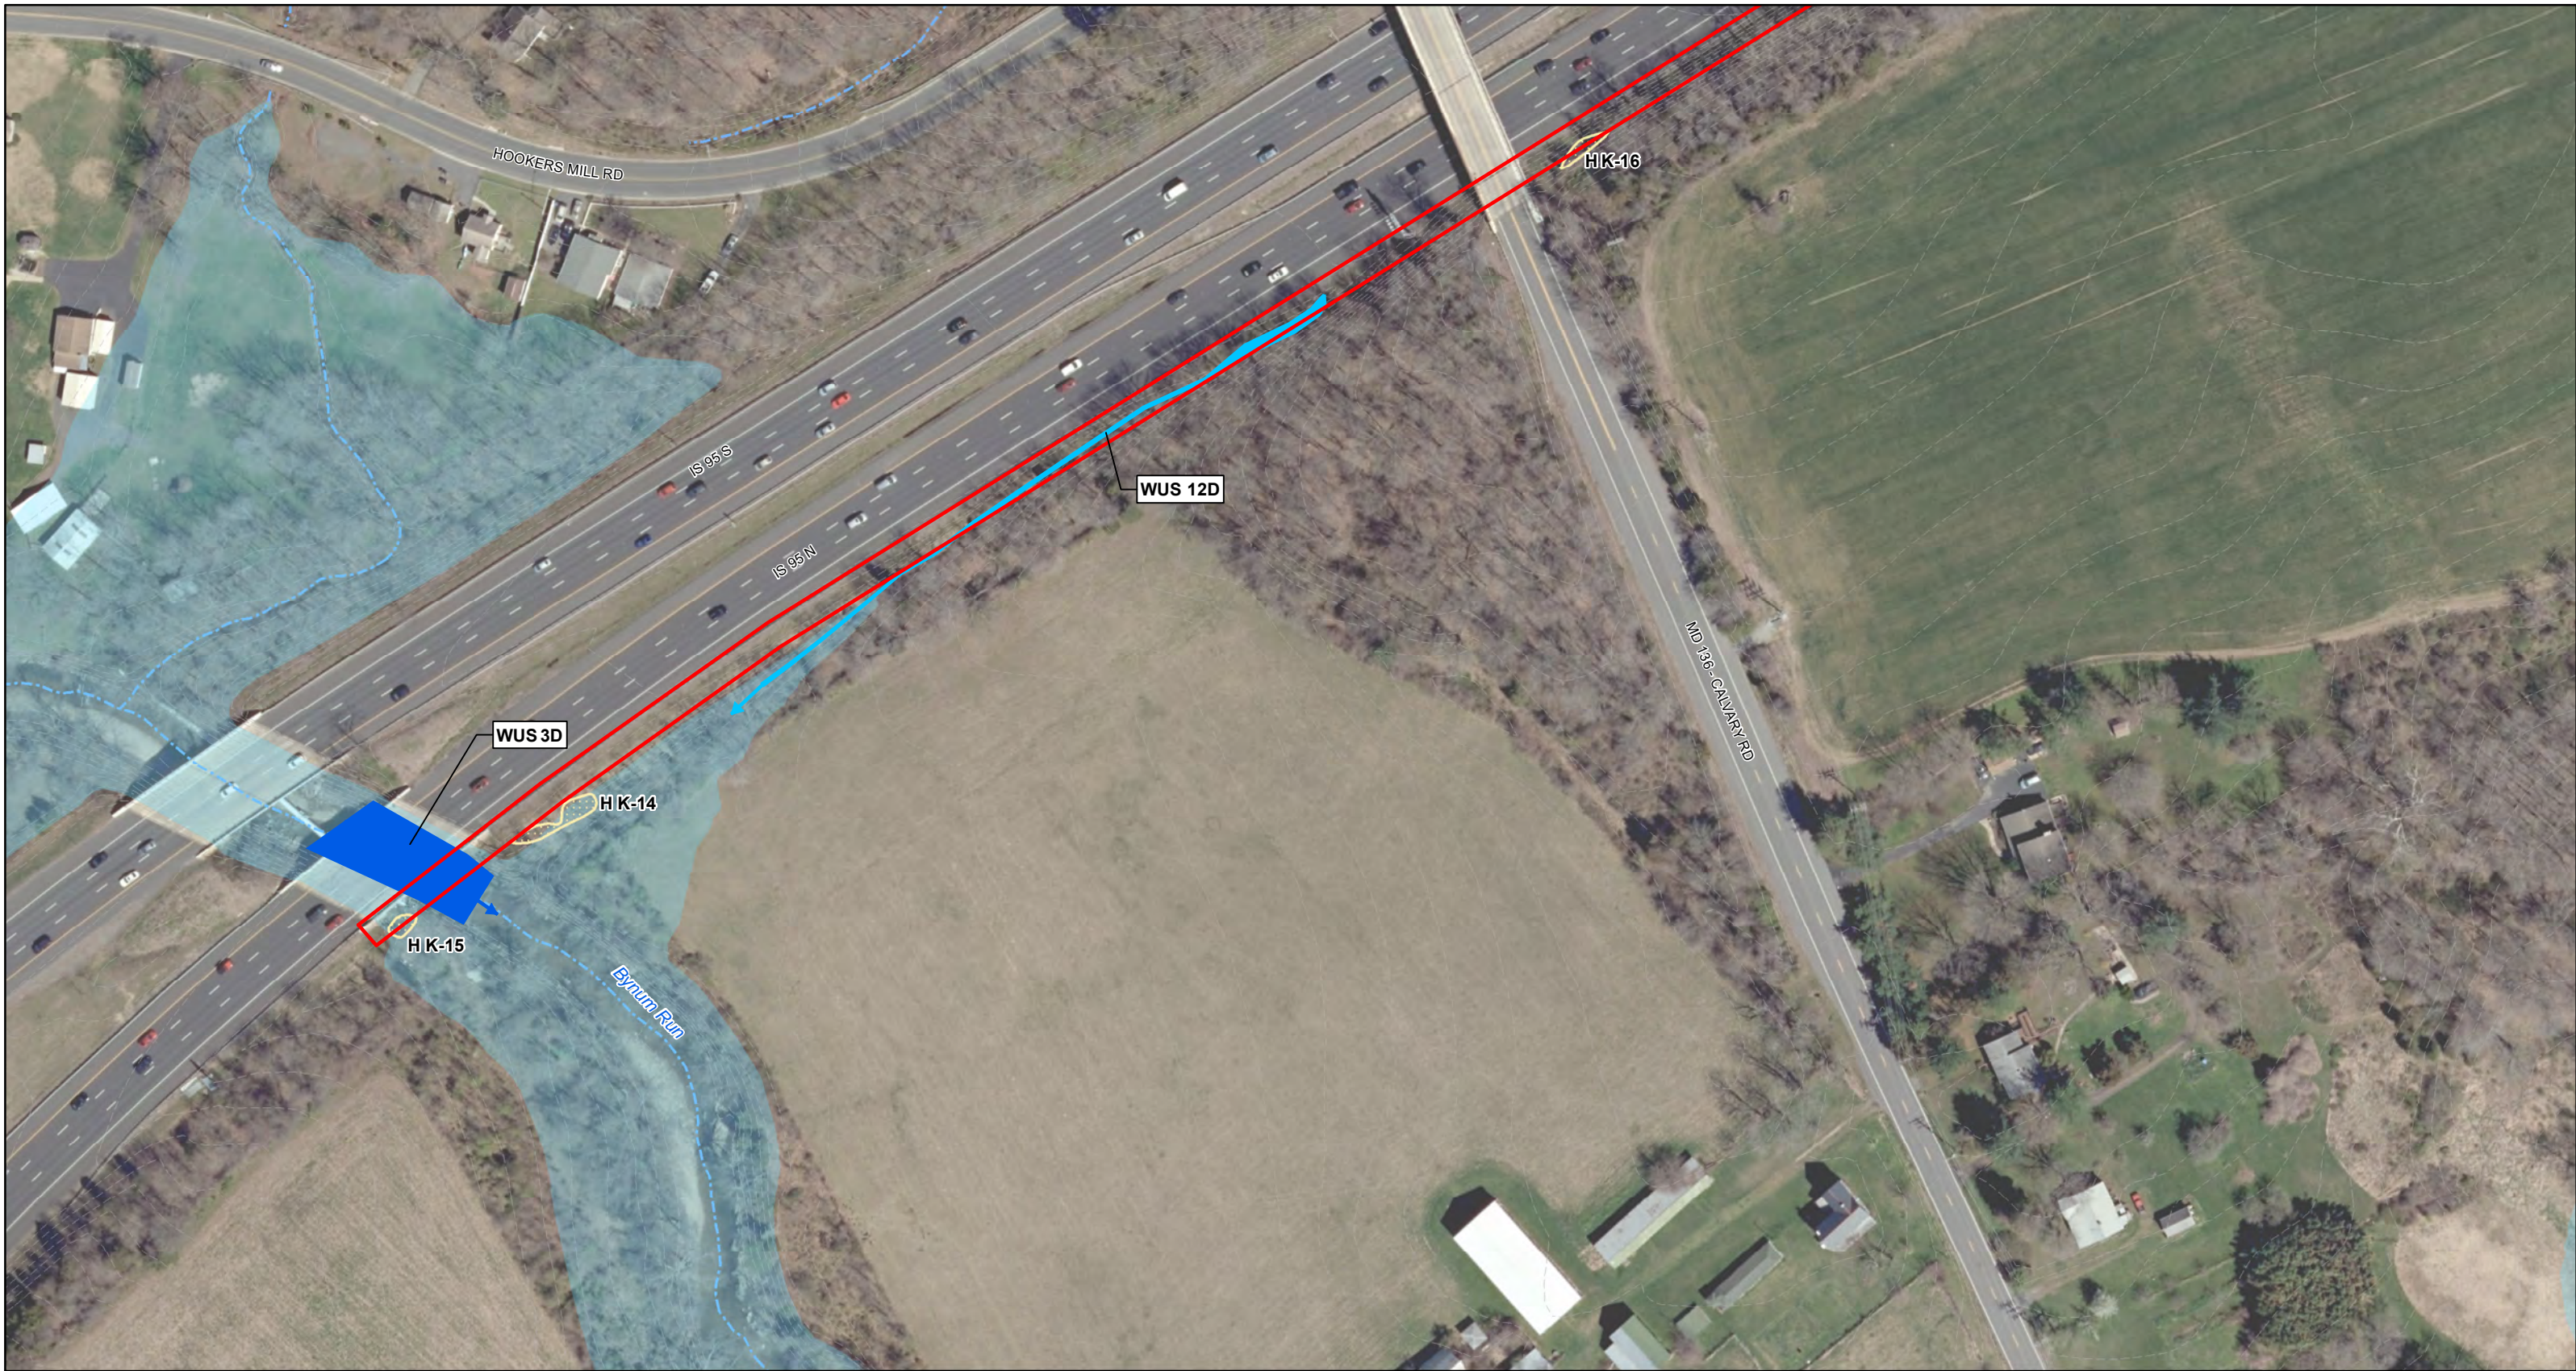
SHEET 3 OF 11
Harford County, MD
July 2019

WUS 3D is the perennial stream Bynum Run (**Appendix B, Sheet 3**). The stream flows south under I-95 and eventually discharges into Bush Creek at the confluence with James Run. The stream channel is approximately 50 feet wide with banks approximately 6 feet high; at the time of the delineation, flow within the channel varied between 1 and 3 feet deep. The substrate consists of cobble, gravel, sand, and rip-rap. The stream is moderate quality within the study area due to extensive pollution and disturbance from the roadway. WUS 3D was previously delineated and included in the *Wetland Identification and Delineation Report for Section 200: I-95, North of MD 43 to North of MD 22* (JMT 2006).

WUS 12D is an intermittent stream that flows southwest from a culvert under I-95 (**Appendix B, Sheet 3**). The stream parallels I-95 and discharges into Bynum Run (WUS 3D) outside of the study area. The channel is approximately 4 feet wide and 1 foot deep; at the time of the delineation, flow within the channel was between 2 and 6 inches deep. The substrate consists of gravel, sand, and silt. The stream is low quality because it appears ditched and receives extensive pollution from road runoff. WUS 12D was previously delineated and included in the *Wetland Identification and Delineation Report for Section 200: I-95, North of MD 43 to North of MD 22* (JMT 2006).

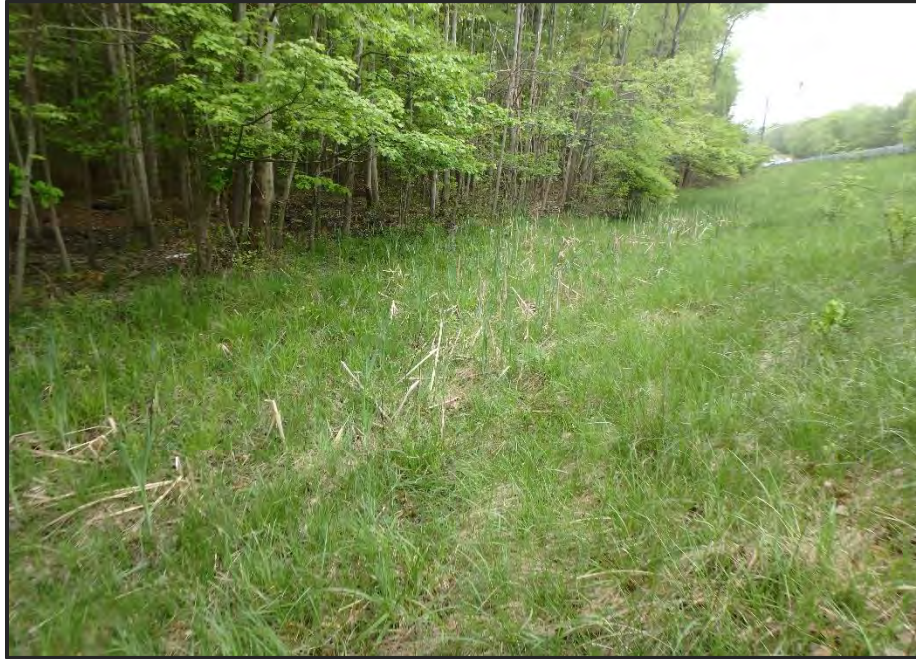
WET E-3 is a palustrine forested and emergent wetland located along the southbound side of MD 152 (**Appendix B, Sheet 9**). It was previously delineated by Johnson, Mirmiran, and Thompson (JMT) in 2019; more information can be found in the KH-3027: MD 152 Park and Ride Relocation section of the *I-95 ETL Northbound Extension Phase II Wetland Delineation Report* (JMT 2019).

Photo 1: WET E-3 PEM (Facing Northwest)

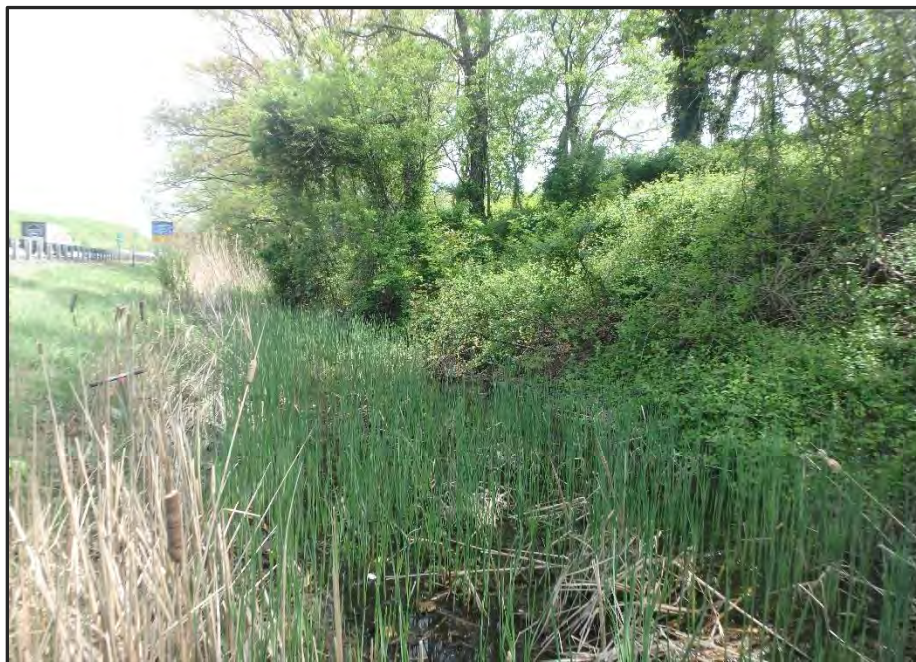
WET K-1 is a palustrine, emergent, persistent, seasonally flooded/saturated (PEM1E) wetland and is approximately 0.03 acres in size. It originates at a culvert under I-95 and extends northeast as a ditch (**Appendix B, Sheet 2**). WET K-1 appears to receive hydrology from road runoff as well as a high water table. WET K-1 continues to the northeast where it drains into WUS 15D and is hydrologically connected to James Run. WET K-1 is a low-quality wetland due to it being a roadside ditch. It provides floodflow alteration and sediment/toxicant retention functions and values. The dominance test for hydrophytic vegetation was met. Dominant plant species in the herbaceous stratum included narrow-leaf cattail (*Typha angustifolia*, OBL). Primary hydrologic indicators observed included surface water, high water table, and saturation. Secondary hydrologic indicators included geomorphic position and the FAC-neutral test. The soil profile met the redox dark surface (F6) indicator. This wetland was previously delineated as part of WUS 15D and included in the *Wetland Identification and Delineation Report for Section 200: I-95, North of MD 43 to North of MD 22* (JMT 2006). This system is currently classified as a wetland rather than a stream due to the presence of all three wetland parameters and a lack of channel characteristics and flowing water.

Photo 2: WET K-1 PEM (Facing Northeast)

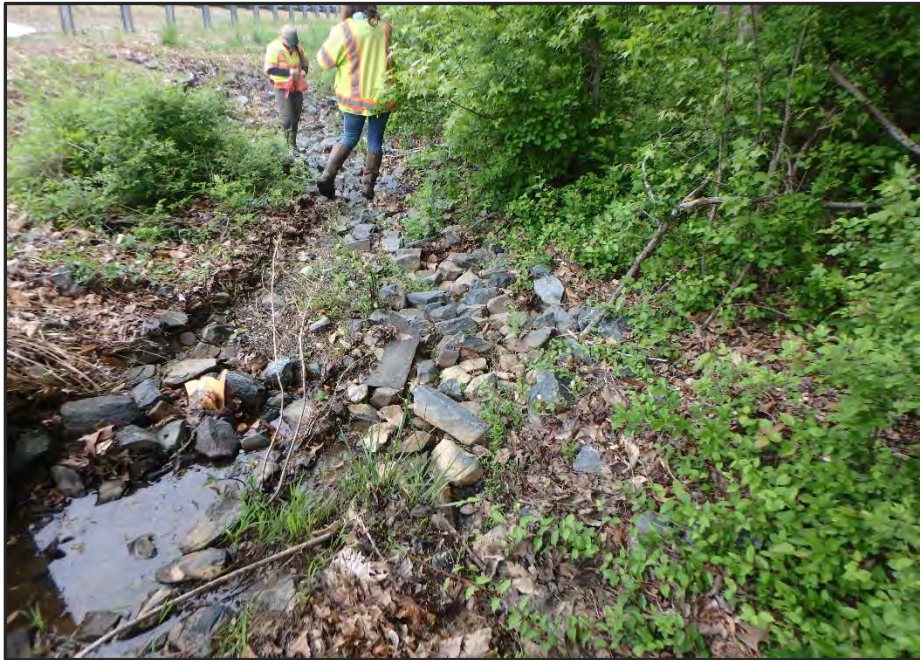
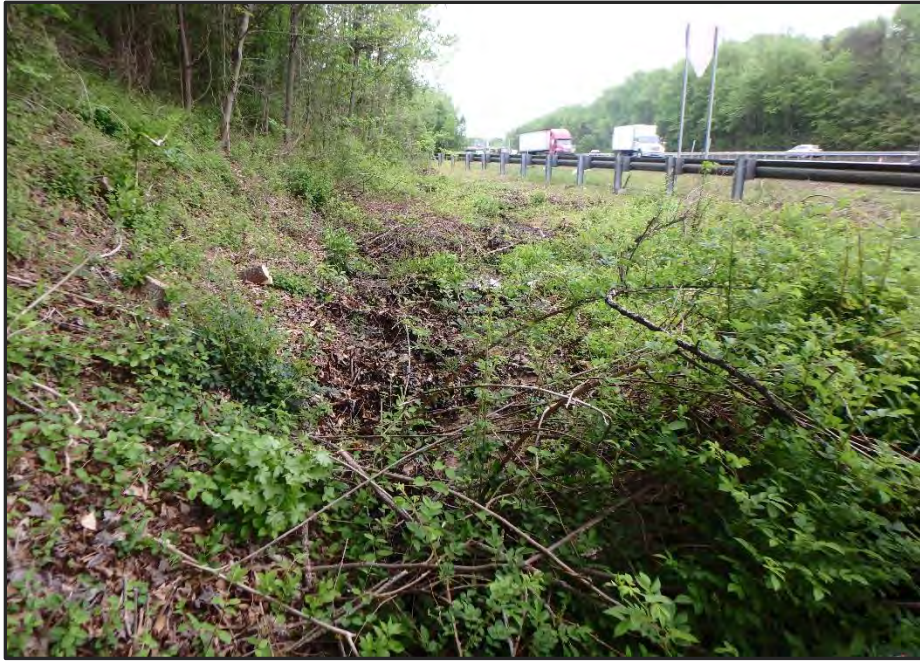
Photo 4: WUS K-6, downstream (Facing West)

Photo 5: WUS K-6, upstream (Facing East)

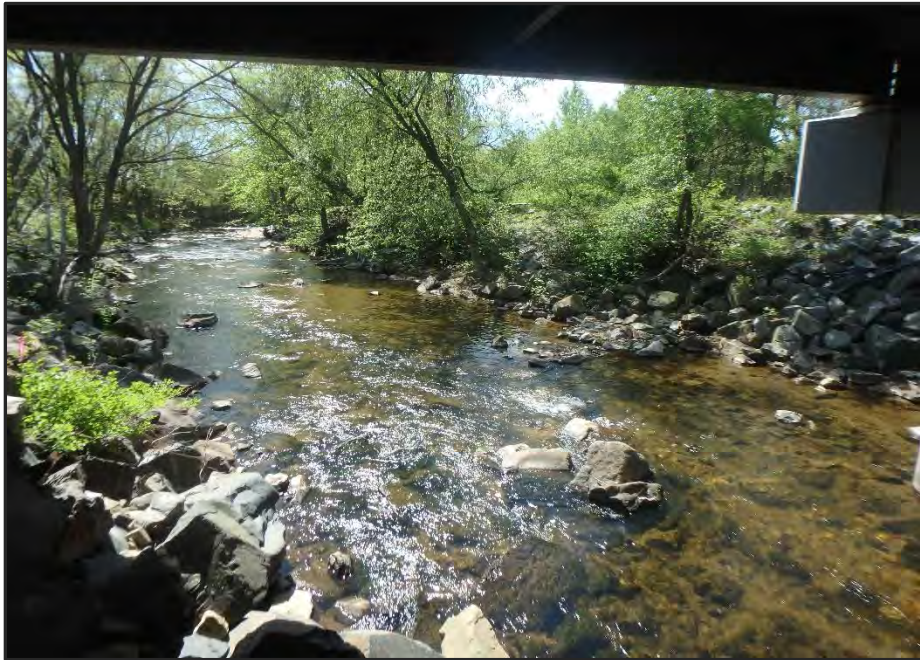
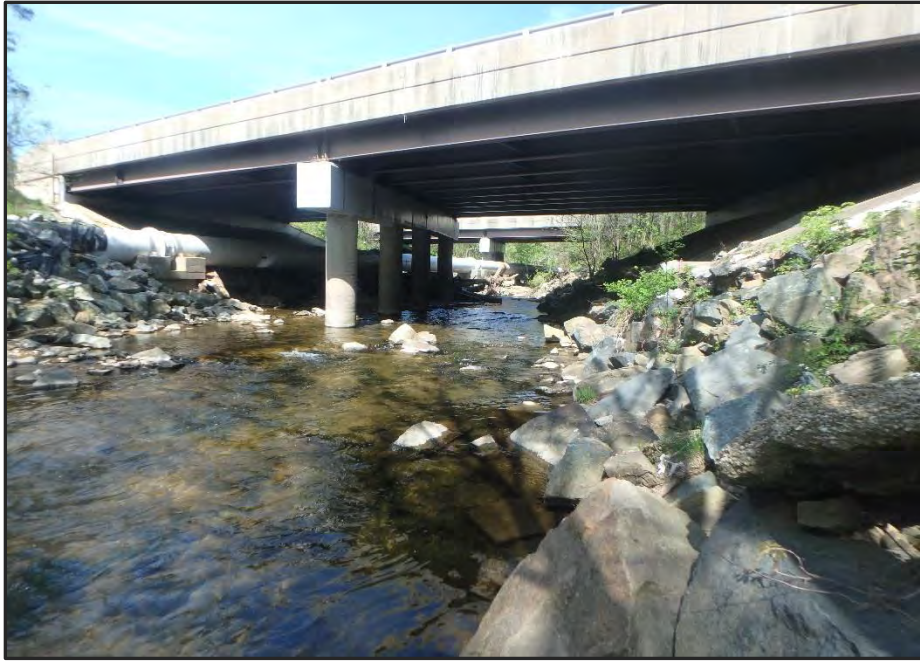
Photo 6: WUS 3D, downstream (Facing Southeast)

Photo 7: WUS 3D, upstream (Facing Northwest)

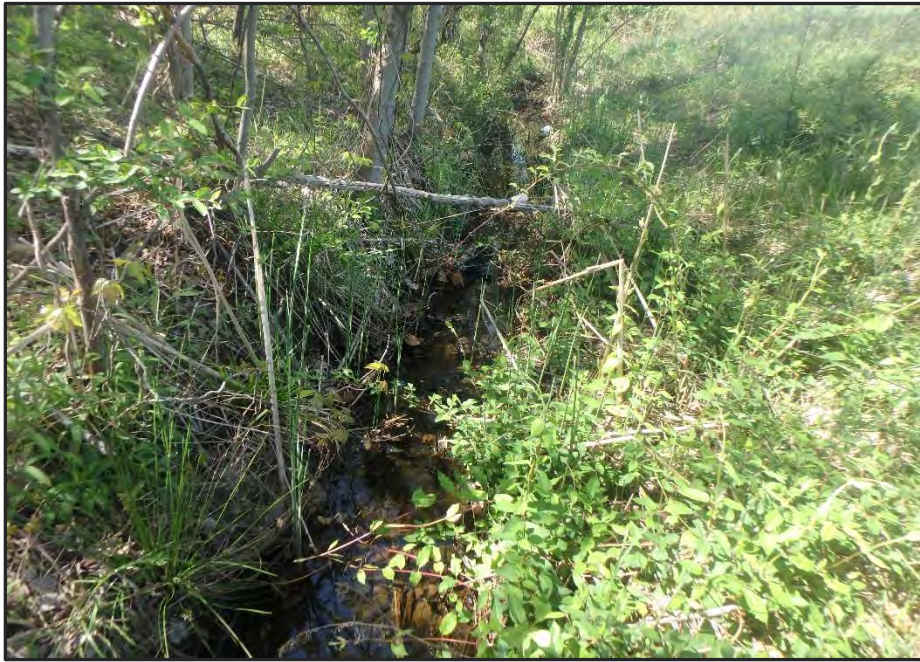
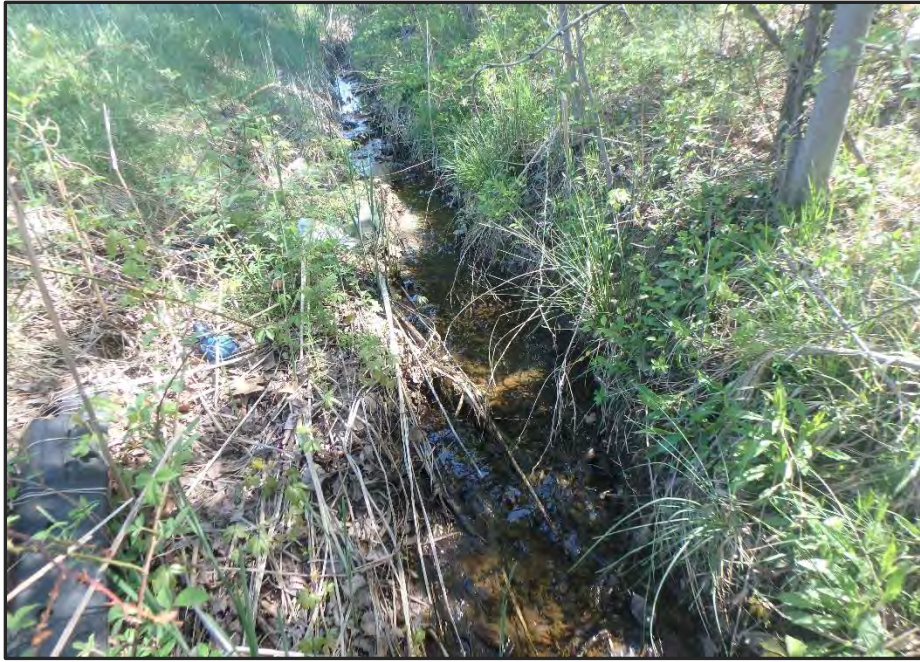
Photo 8: WUS 12D, downstream (Facing Northeast)

Photo 9: WUS 12D, upstream (Facing Southwest)

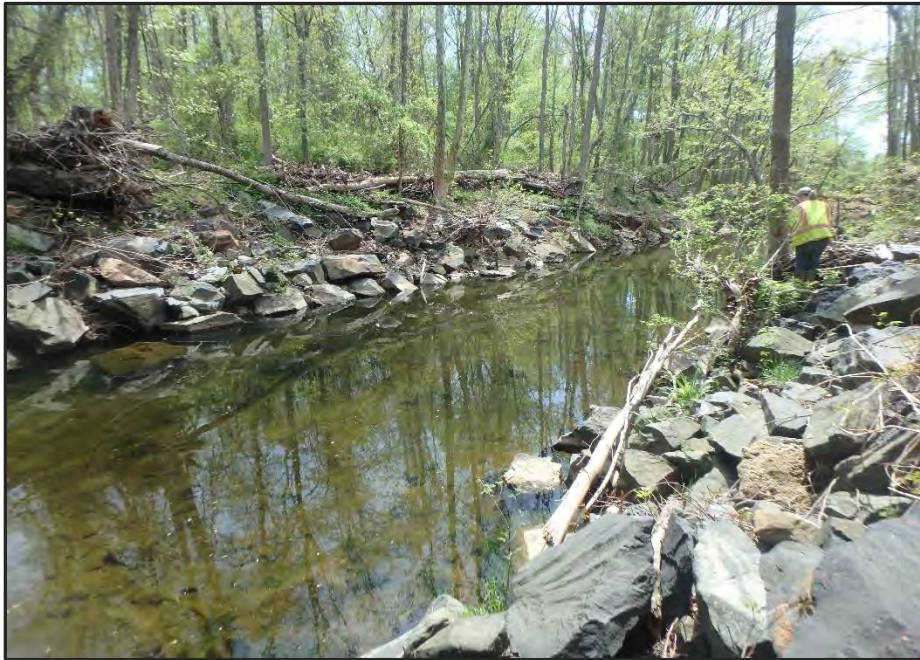
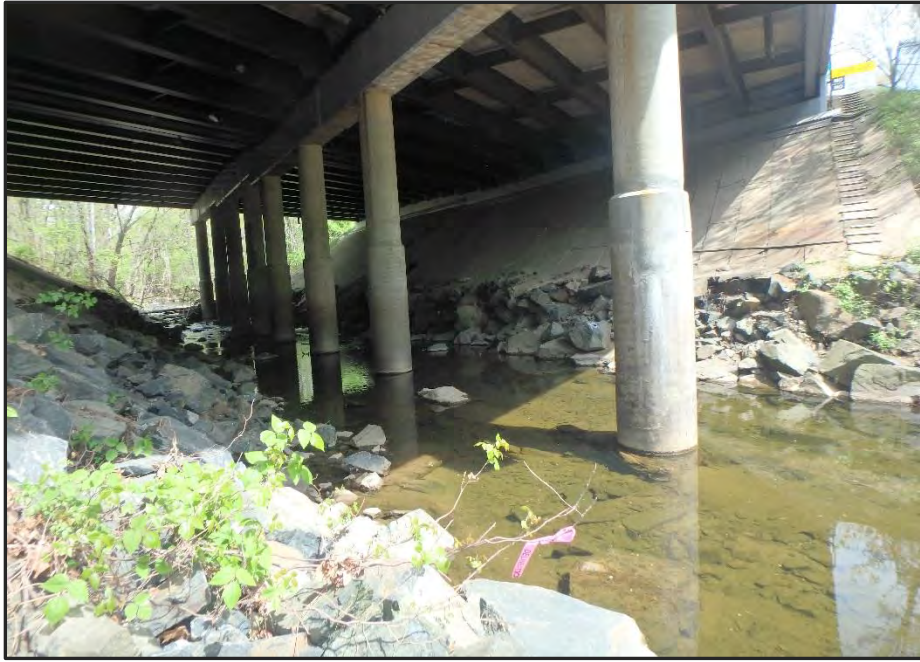
WUS 14D is the perennial stream James Run (**Appendix B, Sheet 2**). The stream flows south under I-95 and eventually discharges into Bush Creek at the confluence with Bynum Run. The stream channel is approximately 40 feet wide with banks approximately 10 feet high; at the time of the delineation, flow within the channel varied between 2 and 4 feet deep. The substrate consists of cobble, gravel, sand, and silt. The stream is moderate quality within the study area due to extensive pollution and disturbance from the roadway. WUS 14D was previously delineated and included in the *Wetland Identification and Delineation Report for Section 200: I-95, North of MD 43 to North of MD 22* (JMT 2006).

Photo 10: WUS 14D, downstream (Facing South)

Photo 11: WUS 14D, upstream (Facing North)

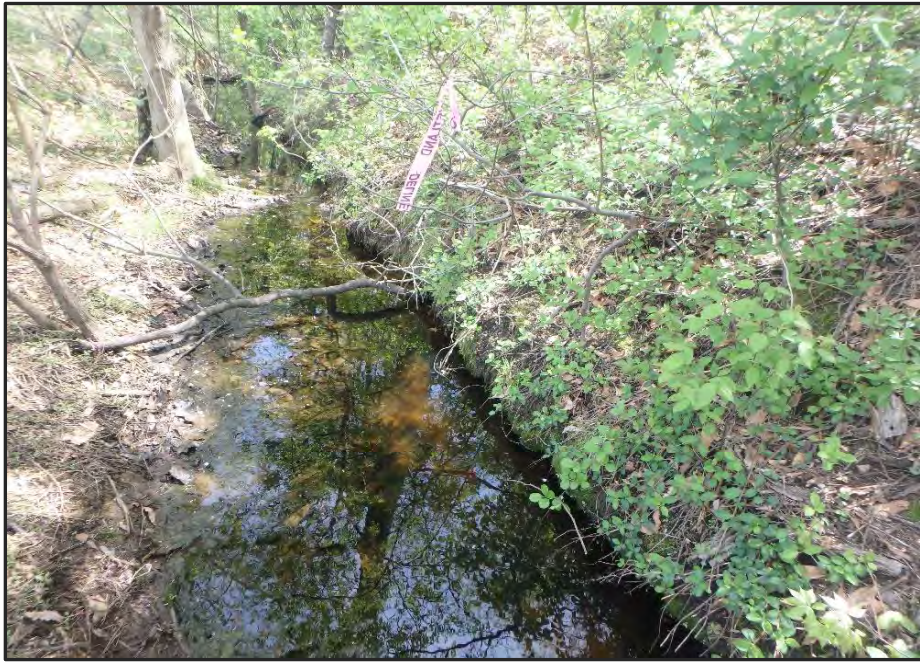
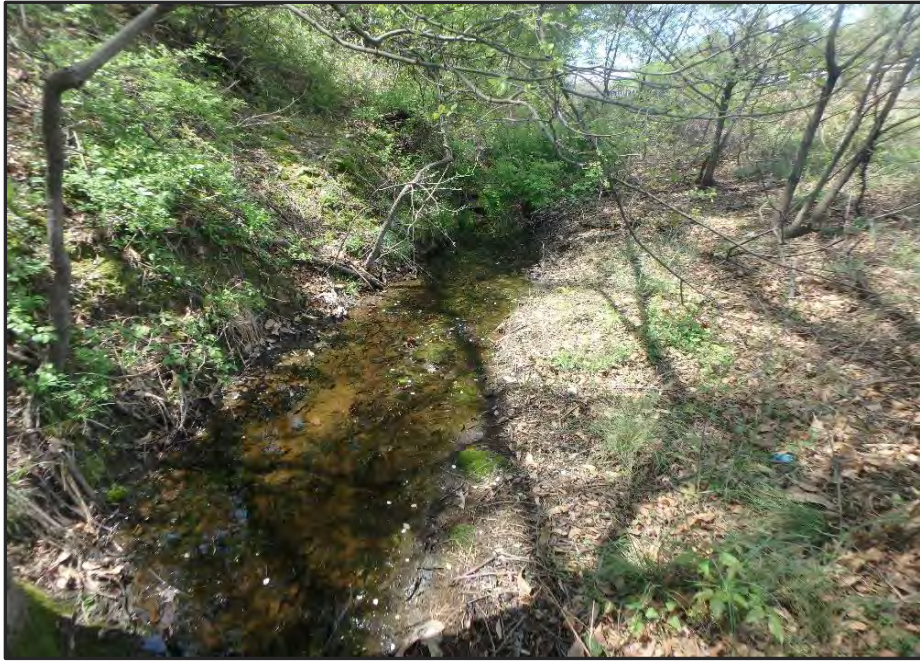
WUS 15D is an intermittent stream that originates at wetland WET K-1 (**Appendix B, Sheet 2**). The stream flows northeast, paralleling I-95 and eventually discharges into James Run outside of the study area. The stream channel is approximately 4 feet wide with banks approximately 1 foot high; at the time of the delineation, flow within the channel varied between 2 and 6 inches deep. The substrate consists of sand and silt. The stream is low quality within the study area because it appears ditched and receives extensive pollution from road runoff. WUS 15D was previously delineated and included in the *Wetland Identification and Delineation Report for Section 200: I-95, North of MD 43 to North of MD 22* (JMT 2006).

Photo 12: WUS 15D, downstream (Facing East)

Photo 13: WUS 15D, upstream (Facing West)

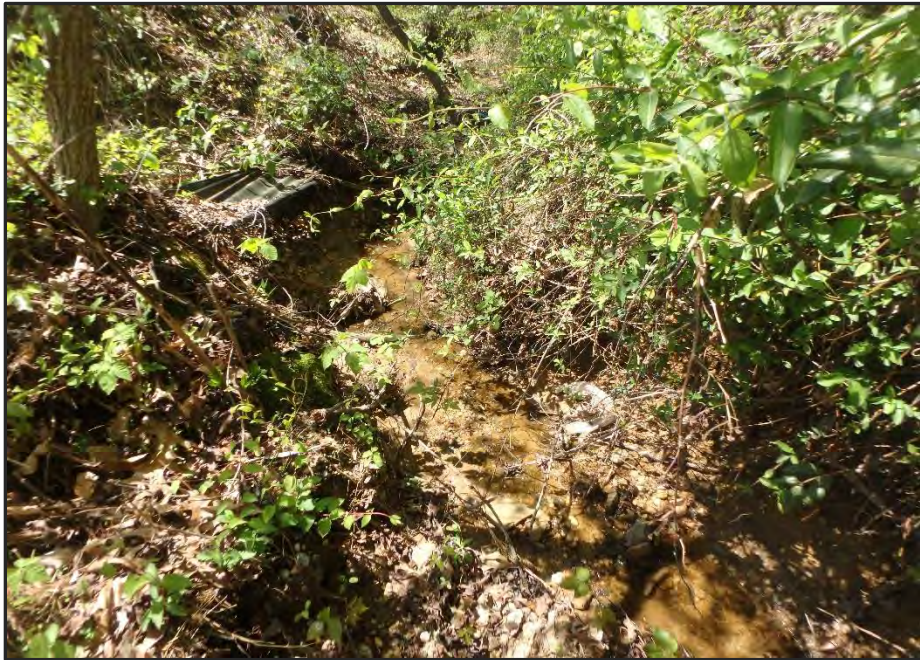
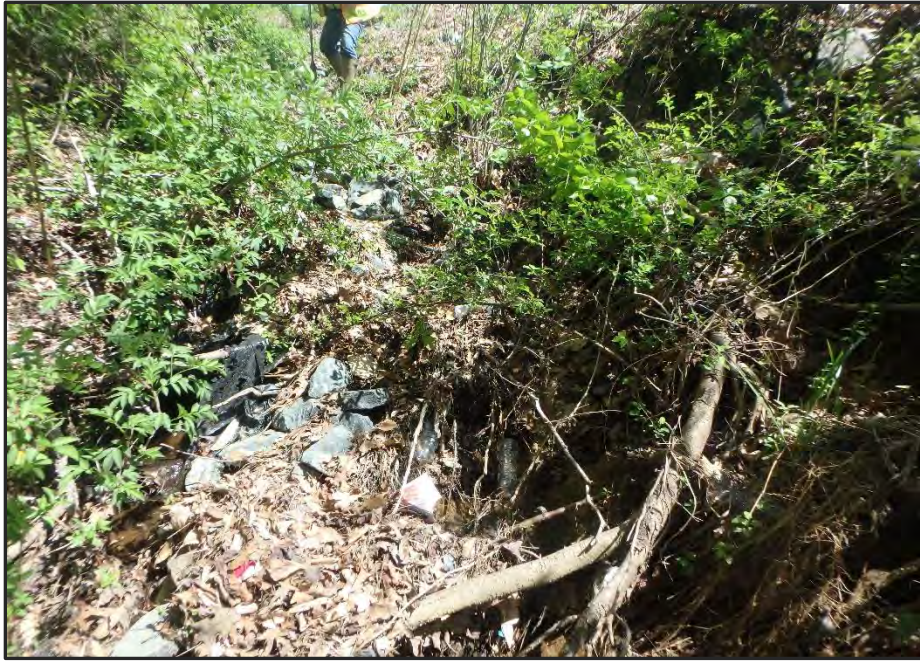
Photo 14: WUS 18D, downstream (Facing Northwest)

Photo 15: WUS 18D, upstream (Facing Southeast)

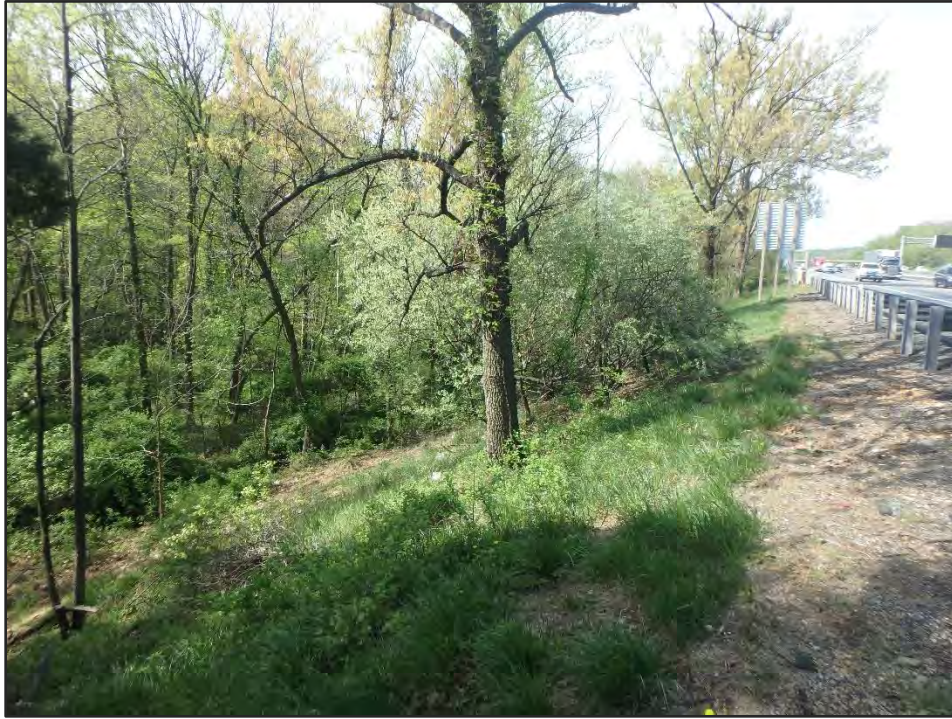
Forest Stand K-2 is located along the northbound side of I-95 around the James River crossing (**Appendix B, Sheet 2**). Forest Stand K-2 is a deciduous, mid-successional forest. Dominant canopy species in this stand include sawtooth oak (*Quercus acutissima*) and sweetgum. Dominant species are predominantly in the 12- to 20-inch DBH size class and 2- to 10-inch DBH size class, with a canopy closure estimated at approximately 80 percent. The co-dominant canopy species includes red maple. The area of the forest stand within the study area is approximately 0.09 acres. FS K-2 continues beyond the study area limits to the southeast.

Overall, Forest Stand K-2 is in fair health with moderate amounts of downed woody debris. The invasive species cover is high at 80 percent throughout the stand in the canopy, understory, and herbaceous layers. Invasive species include sawtooth oak, autumn olive (*Elaeagnus umbellata*), Japanese honeysuckle, rambler rose, Asian bittersweet (*Celastrus orbiculatus*), and common wormwood (*Artemisia vulgaris*). Within the study area FS K-2 is bisected by a perennial stream (WUS K-4) and contains no specimen trees. The stand is ranked as Priority 1 for retention due to the presence of a stream, 100-year floodplain, and steep slopes.

Photo 2: Forest Stand K-2 (Facing South)

11. Comments	Stand K-2 is located along I-95. Forest is in fair condition overall, as it contains many invasives and the <i>Fraxinus pennsylvanica</i> trees are likely dead due to the emerald ash borer. Regenerating species include <i>Fraxinus pennsylvanica</i> and <i>Liquidambar styraciflua</i> . Other non-dominant species include <i>Diospyros virginiana</i> and <i>Robinia pseudoacacia</i> . Downed woody debris is a common feature within the stand.

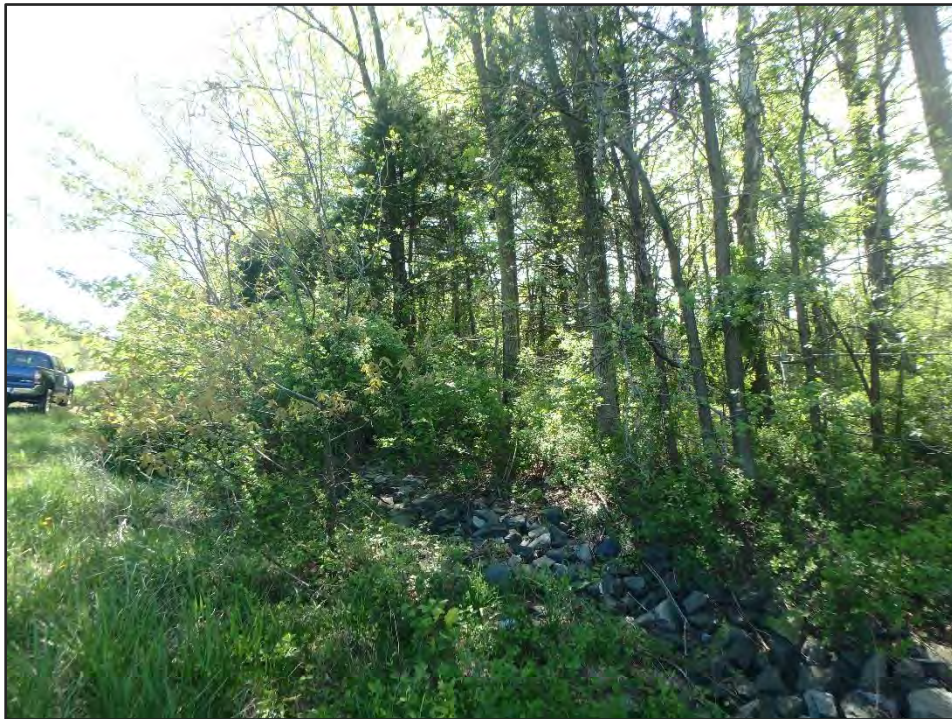
Forest Stand K-3 is in poor health and contains medium amounts of downed woody debris. The invasive species cover is high at 70 percent throughout the stand in the canopy, understory, and herbaceous layers. Invasive species include callery pear (*Pyrus calleryana*), rambler rose, Japanese honeysuckle, Asian bittersweet, and crow garlic. Forest Stand K-3 contains no specimen trees but is ranked as Priority 1 for retention due to the presence of streams (WUS K-5 and WUS K-6) and steep slopes.

Photo 3: Forest Stand K-3 (Facing East)

11. Comments	Stand K-3 is located near the MD-534 interchange. Forest is in poor condition overall, as it contains many invasives and the <i>Fraxinus pennsylvanica</i> trees are likely dead due to the emerald ash borer. Regenerating species include <i>Acer rubrum</i> and <i>Liquidambar styraciflua</i> . Other non-dominant species include <i>Platanus occidentalis</i> , <i>Liriodendron tulipifera</i> , and <i>Juniperus virginiana</i> . Downed woody debris is a common feature within the stand.

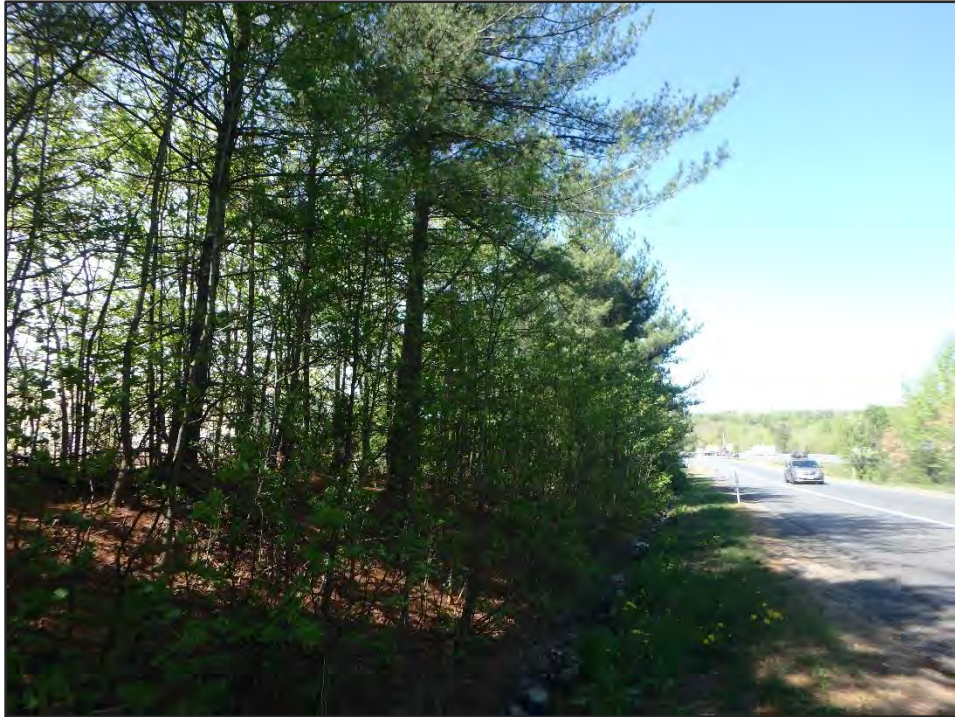
Forest Stand K-4 is in good health and contains little downed woody debris. The invasive species cover is low at 15 percent throughout the stand and only present in the canopy and understory. Invasive species include callery pear and Asian bittersweet. FS K-4 contains no specimen trees or environmentally sensitive areas, is not identified as a priority area by a local land use plan or forest conservation program and is therefore ranked as Priority 3 for retention.

Photo 4: Forest Stand K-4 (Facing Southwest)

11. Comments	Stand K-4 is located along the MD 543 ramp Forest is in good condition overall, as it contains little invasives. Regenerating species include <i>Acer rubrum</i> and <i>Liquidambar styraciflua</i> . Downed woody debris is a rare feature within the stand.

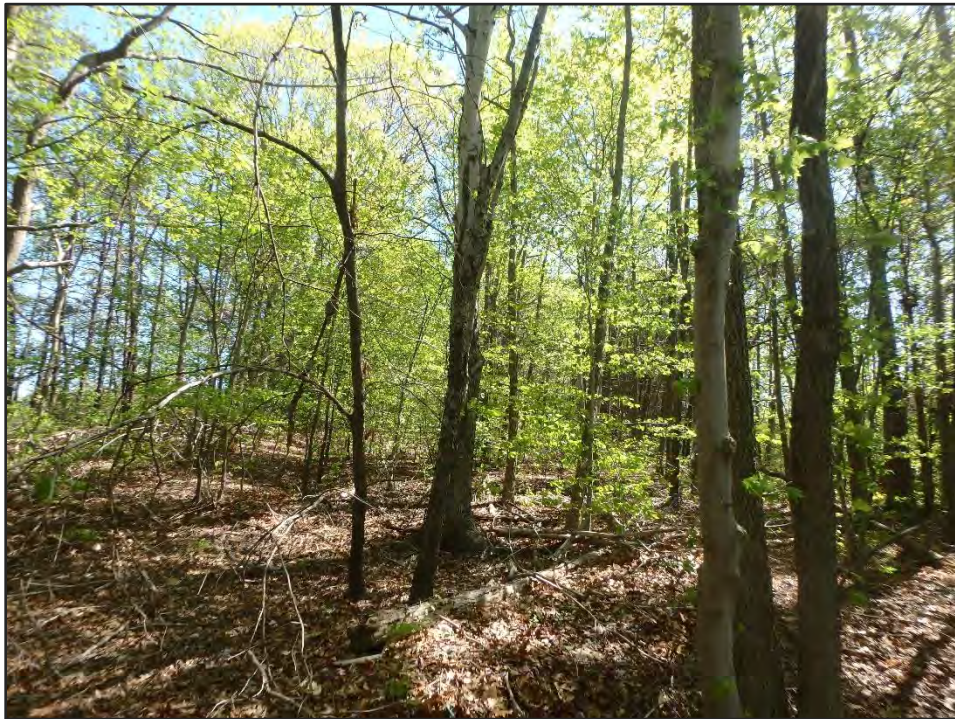
Forest Stand K-5 is in good health and contains some downed woody debris. The invasive species cover is low at 10 percent throughout the stand and only present in the understory. Invasive species include Japanese honeysuckle and rambler rose. FS K-5 contains two specimen trees and is therefore ranked as Priority 1 for retention.

Photo 5: Forest Stand K-5 (Facing Northeast)

10. List of major invasive plant species and percent of cover	<i>Lonicera japonica</i> (V), <i>Rosa multiflora</i> (S) / 10%
11. Comments	Stand K-5 is located within the MD-543 interchange. Forest is in good condition overall, as it contains little invasives and high species diversity. Two specimen trees are located within the stand. Regenerating species include <i>Quercus alba</i> , <i>Quercus rubra</i> , <i>Fagus grandifolia</i> , and <i>Liquidambar styraciflua</i> . Other non-dominant species include <i>Acer rubrum</i> . Downed woody debris is a common feature within the stand.
