MEMORANDUM

Subject: I-95 ETL Northbound Extension – ITS and Sign Installation Study Areas

**APPENDIX B – WETLAND DELINEATION AND FOREST
CHARACTERIZATION/TREE SURVEY MAPS**

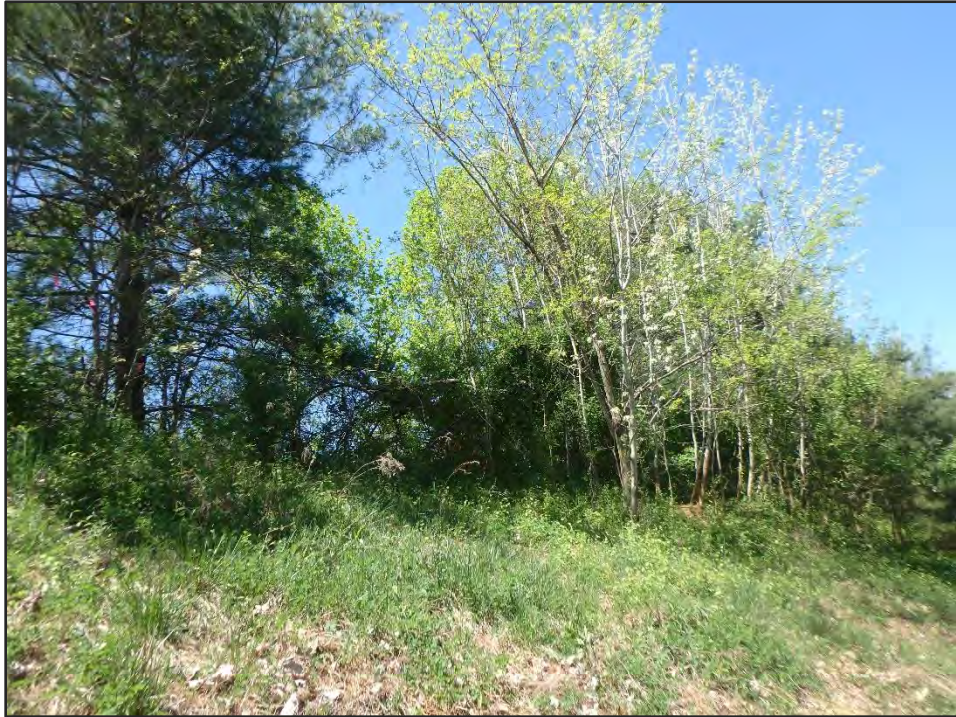
Forest Stand K-6 is located along MD 24 (**Appendix B, Sheet 5 and 6**). FS K-6 is a deciduous/coniferous, early-mid successional forest. Dominant canopy species in this stand include eastern white pine and black locust. Dominant species are predominantly in the 3- to 16-inch DBH size class and 2- to 7-inch DBH class, with a canopy closure estimated at approximately 70 percent. The co-dominant canopy species include big-tooth aspen (*Populus grandidentata*) and Virginia pine. The area of the forest stand within the study area is approximately 0.11 acre. FS K-6 continues west beyond the study area limits.

Forest Stand K-6 is in fair health and contains little downed woody debris. The invasive species cover is moderate at 35 percent throughout the stand and present in the understory and herbaceous layers. Invasive species include Japanese honeysuckle, Amur honeysuckle (*Lonicera maackii*) and crownvetch (*Securigera varia*). Forest Stand K-6 contains no specimen trees however it occurs along a steep slope and is therefore ranked as Priority 1 for retention.

Photo 6: Forest Stand K-6 (Facing Northwest)

11. Comments	Stand K-6 is located along MD 24. Forest is in fair condition overall, as it contains many invasives. Regenerating species include <i>Pinus virginiana</i> and <i>Populus grandidentata</i> . Other non-dominant species include <i>Liquidambar styraciflua</i> . Downed woody debris is a rare feature within the stand.

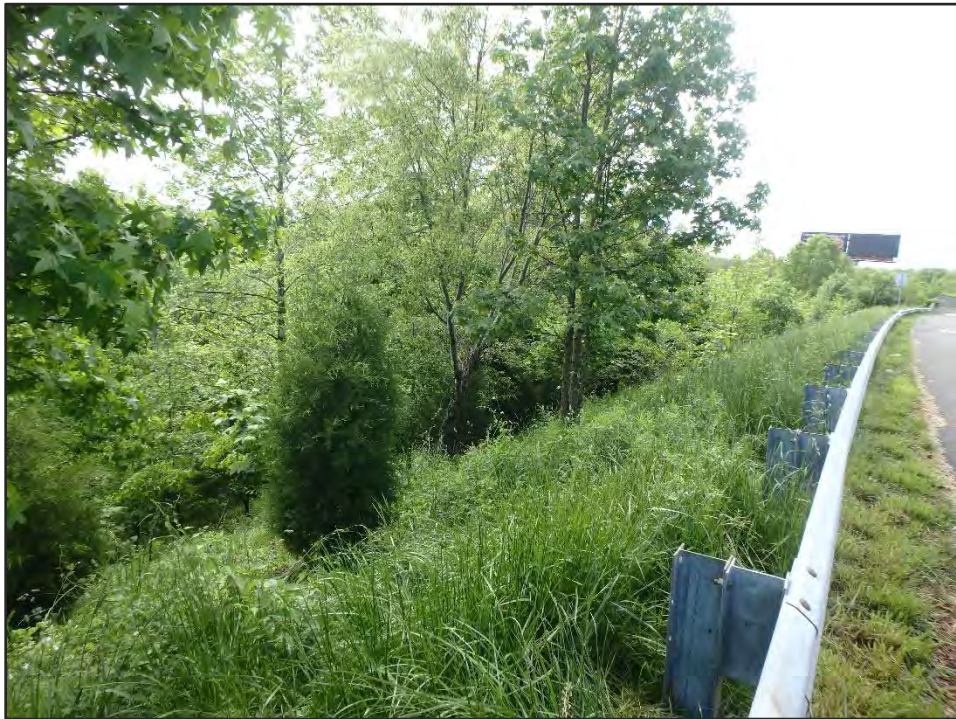
Forest Stand K-7 is located along MD 24 (**Appendix B, Sheet 7**). FS K-7 is a deciduous early successional forest. Dominant canopy species in this stand include sweetgum and tuliptree (*Liriodendron tulipifera*). Dominant species are predominantly in the 2- to 6-inch DBH size class, with a canopy closure estimated at approximately 20 percent. The co-dominant canopy species includes black locust. The area of the forest stand within the study area is approximately 0.02 acre. FS K-7 continues east beyond the study area limits.

Forest Stand K-7 is in good health and contains little downed woody debris. The invasive species cover is low at 5 percent throughout the stand and present only the herbaceous layer. Invasive species include Canadian thistle (*Cirsium arvense*). FS K-7 contains no specimen trees however it is located along a steep slope and is therefore ranked as Priority 1 for retention.

Photo 7: Forest Stand K-7 (Facing South)

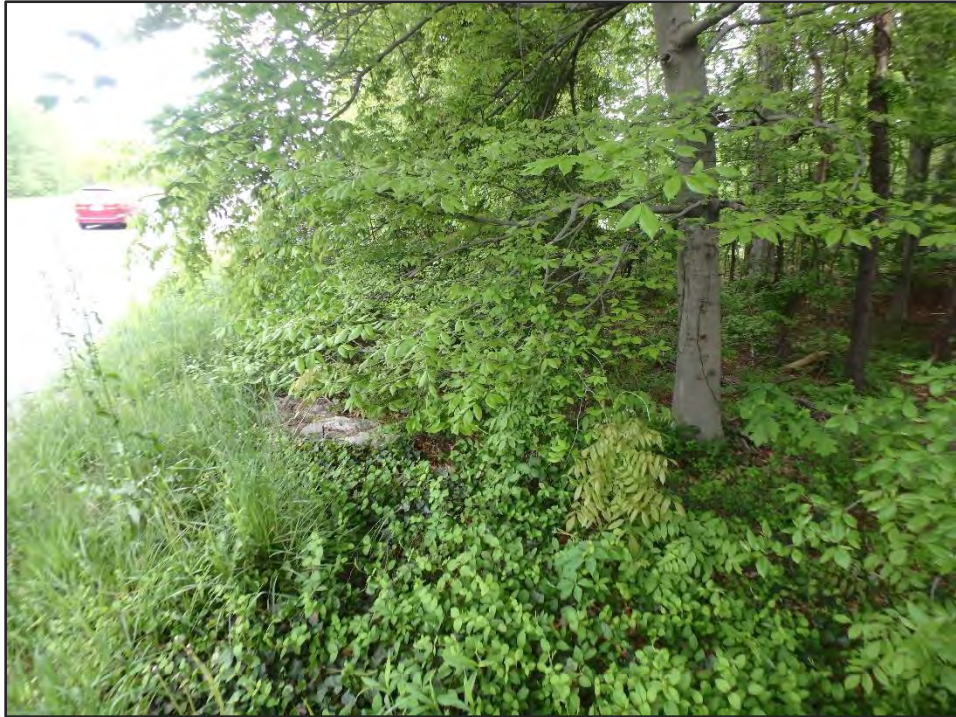
Forest Stand K-8 is located along MD 24 (**Appendix B, Sheet 7**). FS K-8 is a deciduous, early-mid successional forest. Dominant canopy species in this stand include red maple and tuliptree. Dominant species are predominantly in the 3- to 18-inch DBH size class and 6- to 25-inch DBH class, with a canopy closure estimated at approximately 70 percent. The co-dominant canopy species include American beech, northern red oak, and white oak. The area of the stand within the study area is approximately 0.01 acre. FS K-8 continues east beyond the study area limits.

Forest Stand K-8 is in good health and contains moderate amounts of downed woody debris. Invasive species cover is low at 10 percent and is present in the understory and herbaceous layers. Invasive species include callery pear, common mugwort (*Artemisia vulgaris*), and Japanese honeysuckle. FS K-8 contains no specimen trees or environmentally sensitive areas, is not identified as a priority area by a local land use plan or forest conservation program and is therefore ranked as Priority 3 for retention.

Photo 8: Forest Stand K-8 (Facing North)
