Westbound Bay Bridge Deck Rehabilitation Project Update

Existing WB Bay Bridge

Overall Scope of Work

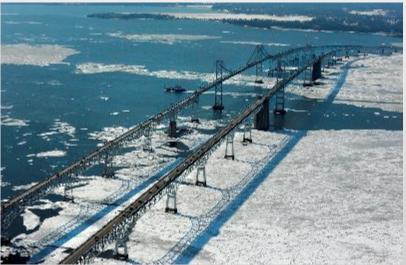
View of WB Left Lane emergency replacement in 2004

- Constructed in 1973 21,051 LF ± of structure with 122 spans
- Two-lanes with curb-to-curb width of 38 FT \pm
- O WB Deck and Overlay Replacement history
 - 2002 to 2004 replaced decks in select beam & girder spans (est. 21% of area) and micro-silica fume (MS) overlays of all other spans, except Suspension & Thru Truss spans.
 - 2004 to 2005 replaced portions of Center and Left Lanes having defective MS overlays with new latex modified concrete (LMC) overlays (est. 33% of area). Right lane not replaced.
 - 2007 to 2010 replaced deck and floor system of Suspension & Thru Truss spans (est. 21% of area).

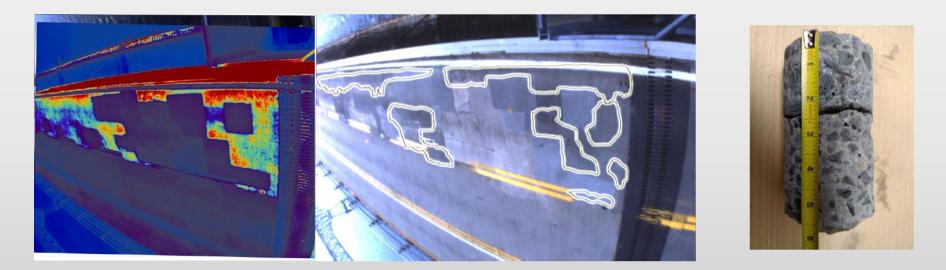
- NDT program findings indicate internal repair needs
- Physical soundings, inspection and coring program performed to validate NDT
- This presents a number of safety risks given the frequency of patching and emergency holding patches

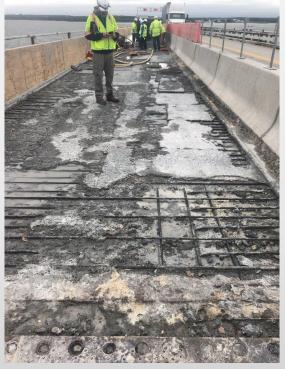
Actual deck conditions demonstrate that work is needed now to avoid longer and more costly redecking:

Milling operations removing below reinforcing in numerous areas
