## **DRAFT COMPENSATORY MITIGATION PLAN**

*Governor Harry W. Nice Memorial Bridge Improvement Project*

**July 2009**

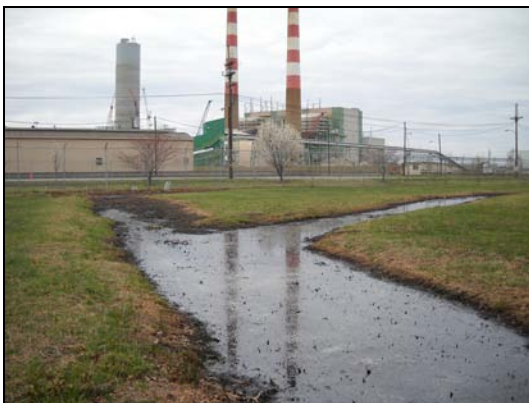
*Photo #1.* Emergent Wetland

The functions and values of the impacted resources are detailed in *Tables 2 and 3*. The emergent wetland is located in an open, mowed field, does not appear to be connected to the water table, and stormwater runoff is its primary water source (see *Photo #1*). It provides

some function for flood storage during and after storm events, and habitat for limited fauna. The Potomac River provides ten out of the thirteen potential functions and is home to several resident and migrating species. Numerous types of recreation occur on the Potomac River, and it contains many Uniqueness/Heritage values including archeological sites, unique plants and geologic features.

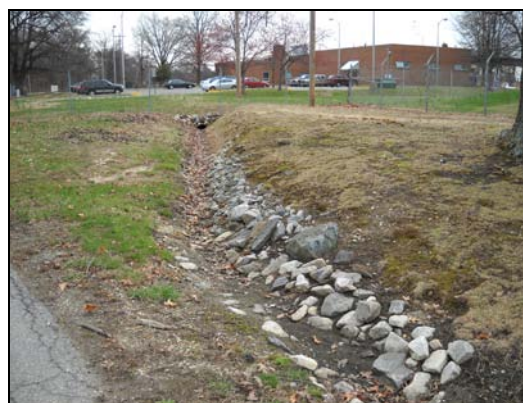
*Photo #2.* Ephemeral roadside ditch at Nice Bridge

The ephemeral roadside ditches (see *Photo #2*) are riprap, dirt bottom and/or concrete channels draining uplands, and provide minor value for nutrient removal. These resource function and values will be considered during the alternate selection process and will result in the application of avoidance and minimization measures during design. Accordingly, the same functions and values were considered during the development of the CMP and their replacement/enhancement is a primary design goal at the proposed mitigation sites.

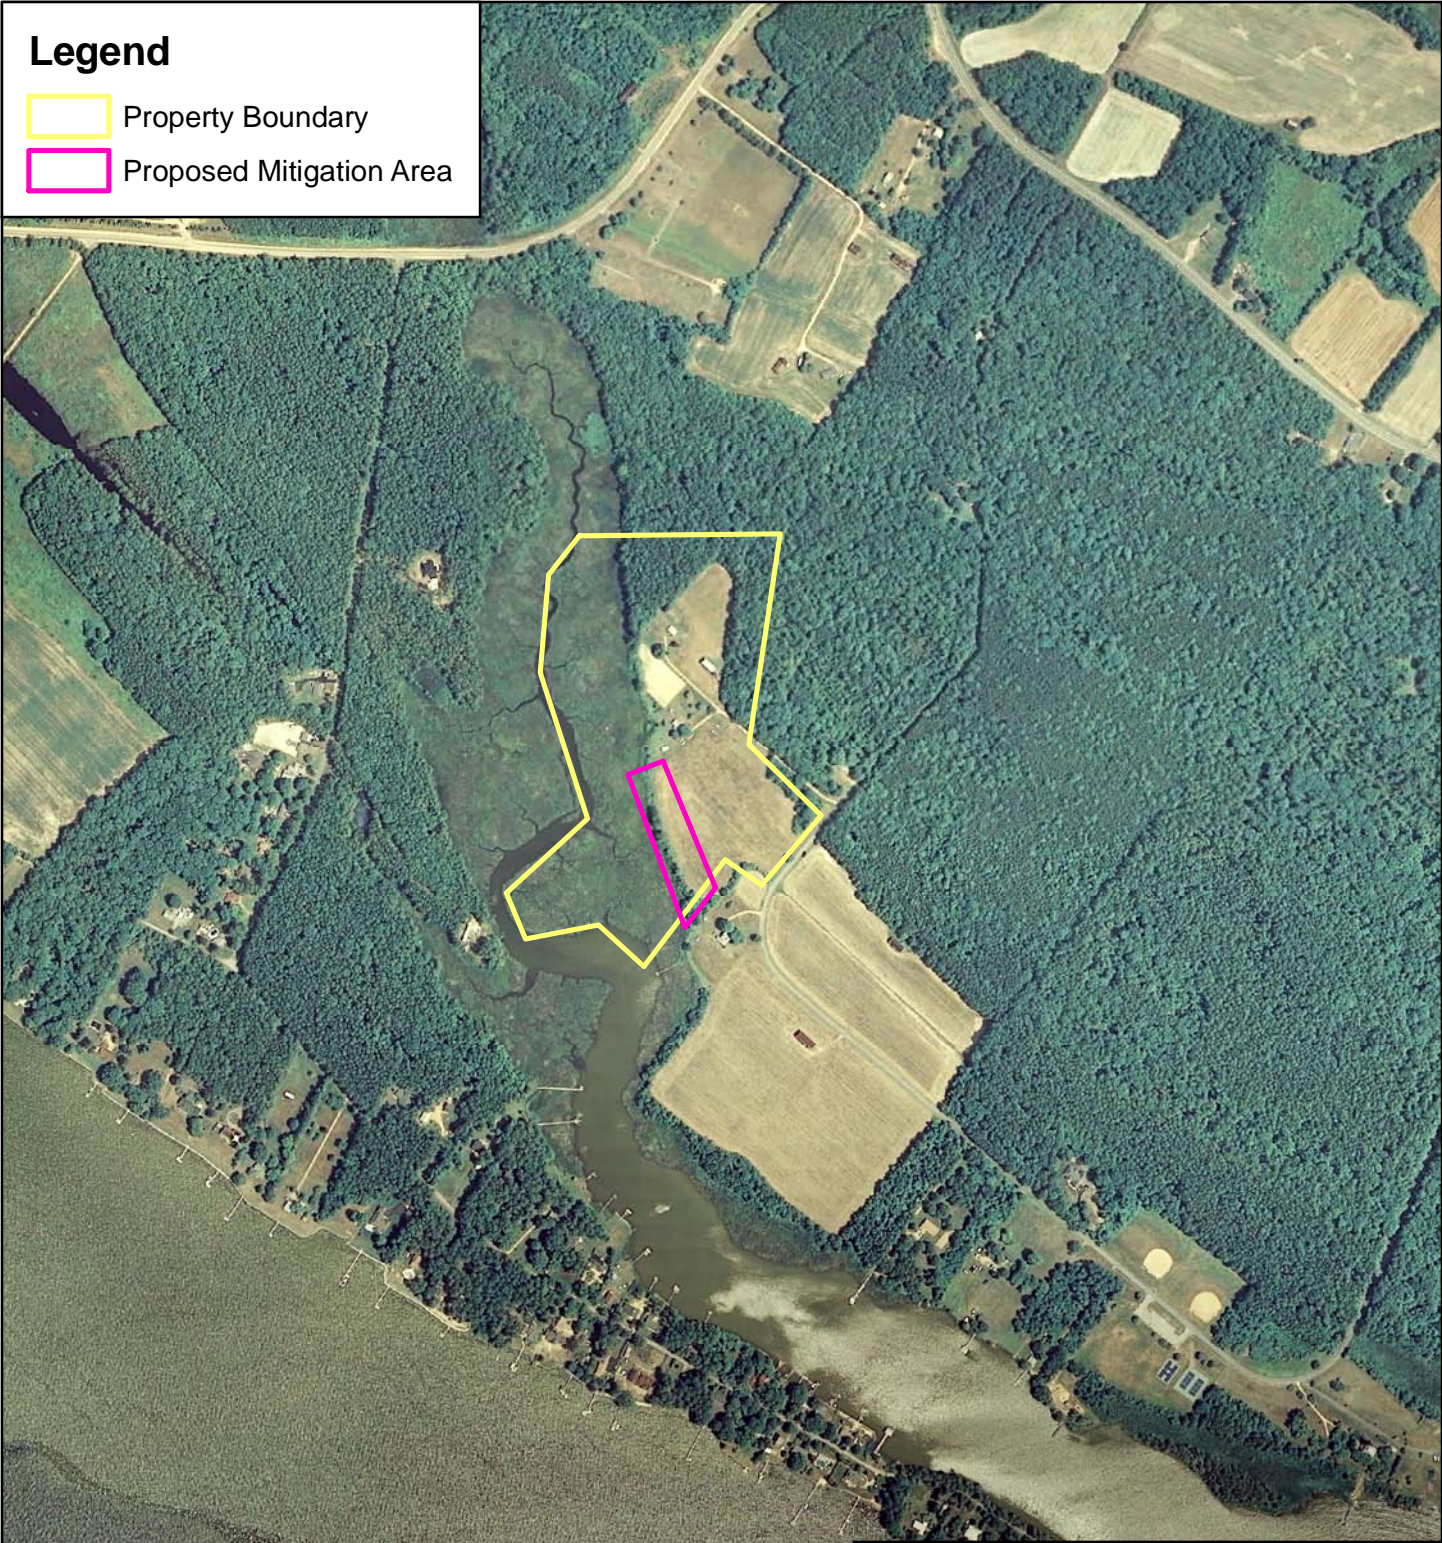
**Existing Conditions** - Site #13 (Figure 7) is located on Neale Sound, a tidal tributary to the Potomac River. The site is currently leased for soybean farming. The soils are Mattapeake Silt Loam on 0 to 2% slopes, which is a non-hydric soil series.

**Proposed Project** - The site has potential for approximately 0.667-acre marsh creation, which would enhance the marsh that exists adjacent to Neale Sound. Marsh creation on this property would entail minimal excavation to achieve inundation by the Spring high tide or saturation by groundwater. Any topsoil would be salvaged and replaced. Because the water table is influenced by tides, it would be relatively easy to establish the elevations that would be suitable to sustain wetland hydrology. The excavation of the site would result in a steeper slope landward of the created marsh. The new slope would be planted with native species to provide an upland buffer. This site is also considered moderate to high probability for an archeological site, and would likely require some level of cultural resource investigation, or coordination with the Maryland Historical Trust.
