April 2021

ECCLESTON MITIGATION SITE DESIGN REPORT

MDTA Contract No. KH-3038-0000

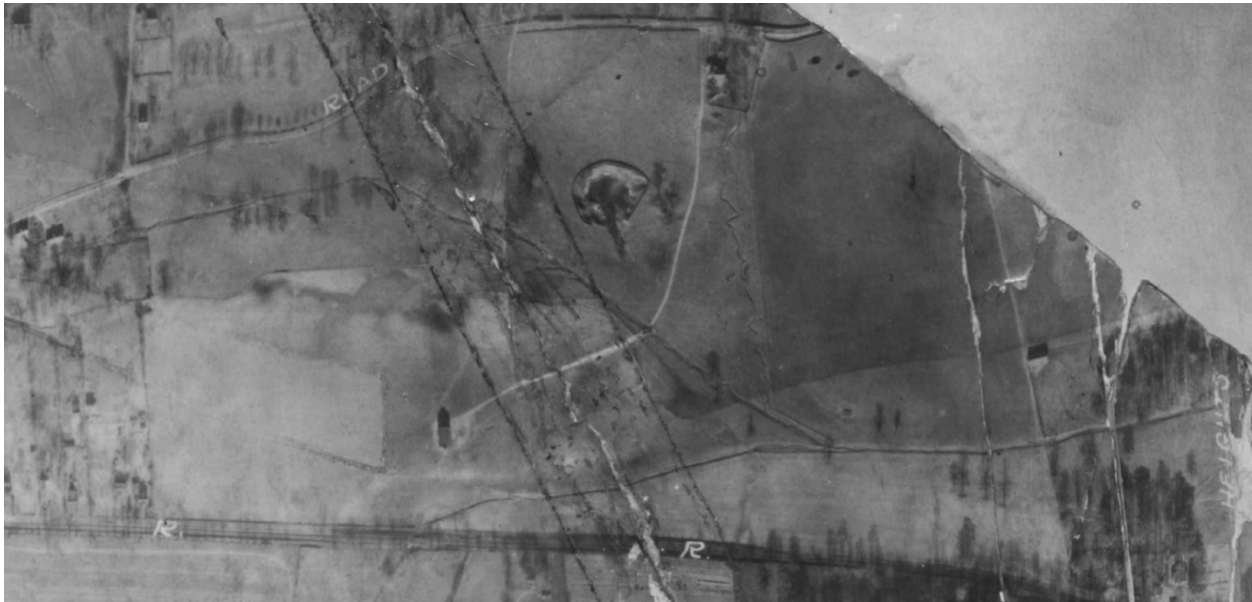
Figure 2: 1927 Aerial image of the site. Note extensive ditching, draining, and lack of forest cover

Historic aerials of the site show that the channel has been altered significantly, with meanders being straightened and adjusted throughout the aerial period. Aerials from 1927 and 1953 were consulted along with historic maps (**Figures 2 and 3**).

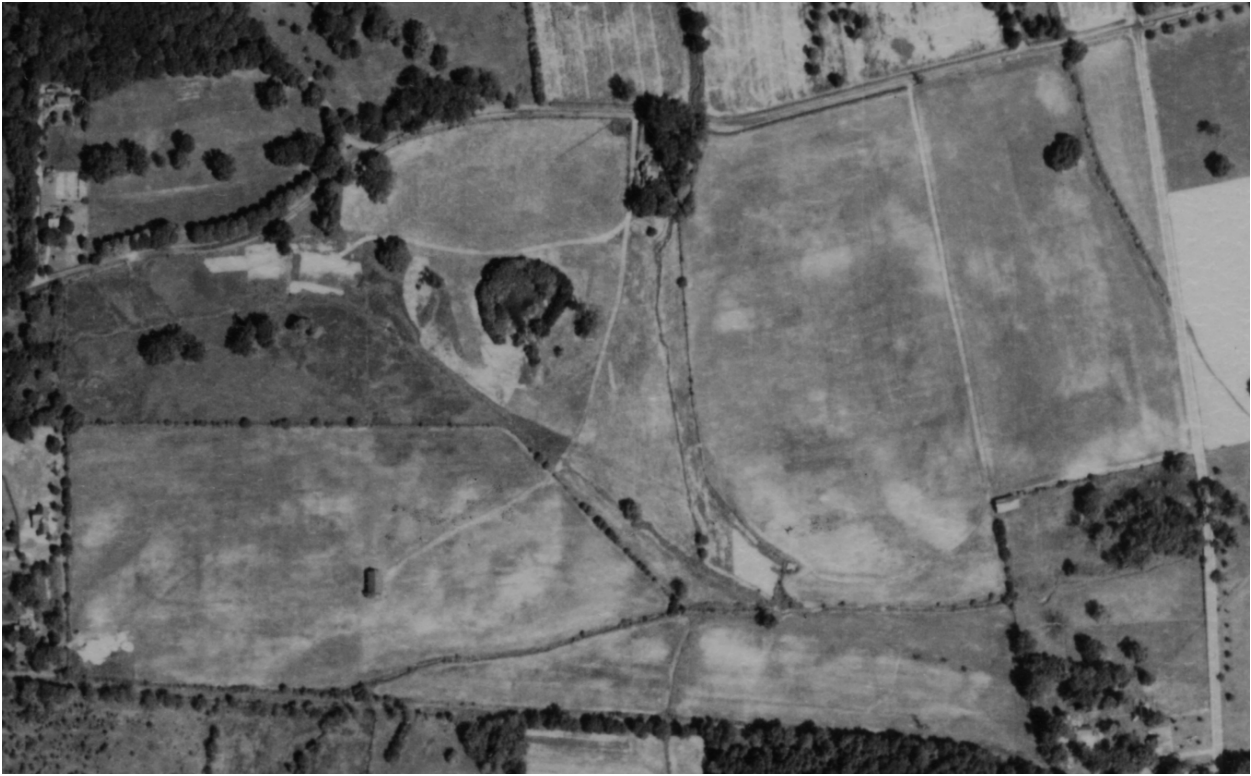
Figure 3: 1953 aerial image of the site

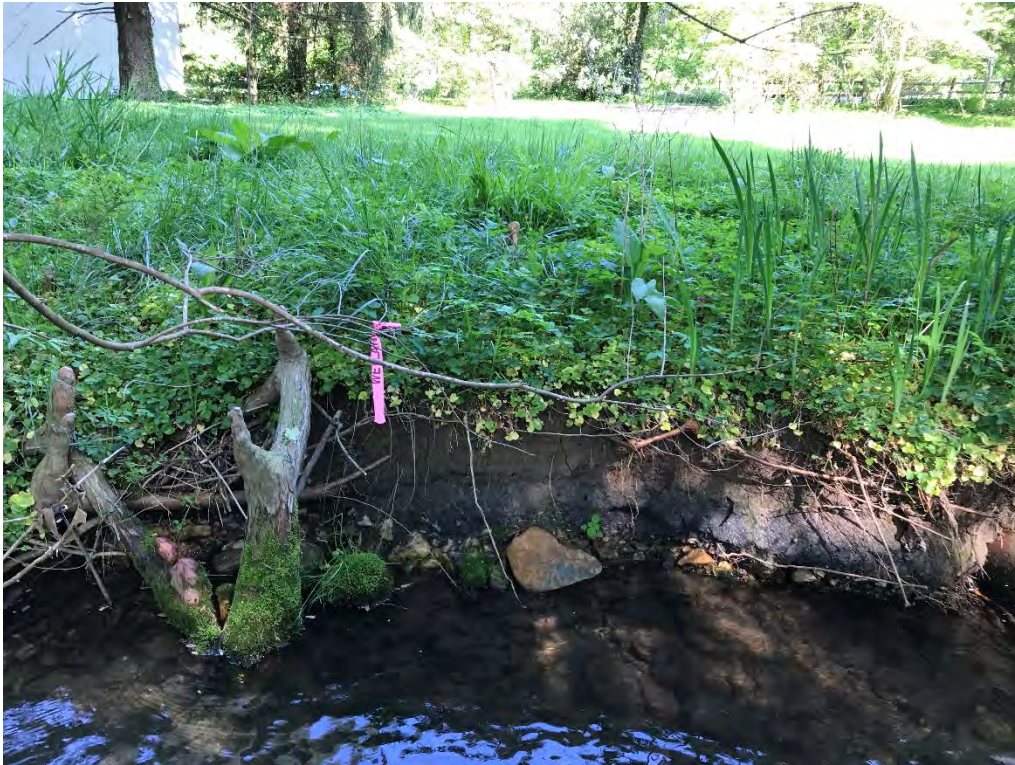
Figure 4: Buried basal gravels, below hydric soil observed at base of stream banks

Damming of the Jones Falls and tributaries is evident on the project site. Historic damming of the Jones Falls may not be limited to those observed in the present day. All of the historic indicators of Legacy Sediments as described in the works of Robert Walters and Dr. Dorothy Merritts at Franklin and Marshall College are present throughout the main stem of the project site. A dense, relatively impervious layer of sediment is located above a hydric soil layer containing wood, seeds, and other evidence of a previously thriving floodplain wetland complex. Below this hydric soil layer exists a basal matrix-supported gravel layer, indicative of the periglacial processes which formed the present-day landscape following the last ice age in Maryland, when this area was a tundra ecotype (**Figure 4**).

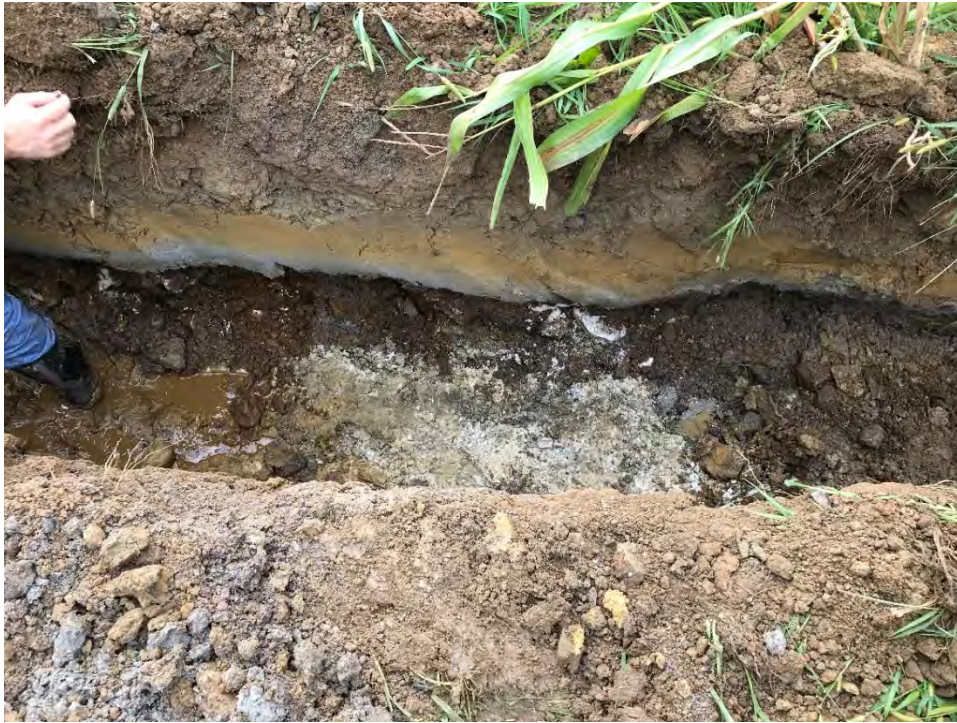
Figure 5: Trench along the main stem of the Jones Falls showing where layers of hydric soil and basal gravel were found

Through the trenching investigation, MDTA was able to observe a very strong hydric soil layer and basal gravel geology through the entire main stem Jones Falls stream valley (**Figures 5 and 6**). This layer had minor disturbances, presumably from agriculture. MDTA has also observed that the majority of the main stem of the Jones Falls has been trenched and relocated to the right side of the valley (right as observed looking downstream). The final approximately 600 LF of the main stem approaching the Park Heights Avenue culvert appears to be trenched and located centrally in the valley, with geologic indicators occurring strongly on both banks. Groundwater was strongly observed in trenches, with trenches rapidly filling with groundwater and commonly associated with pockets of buried clean sands.

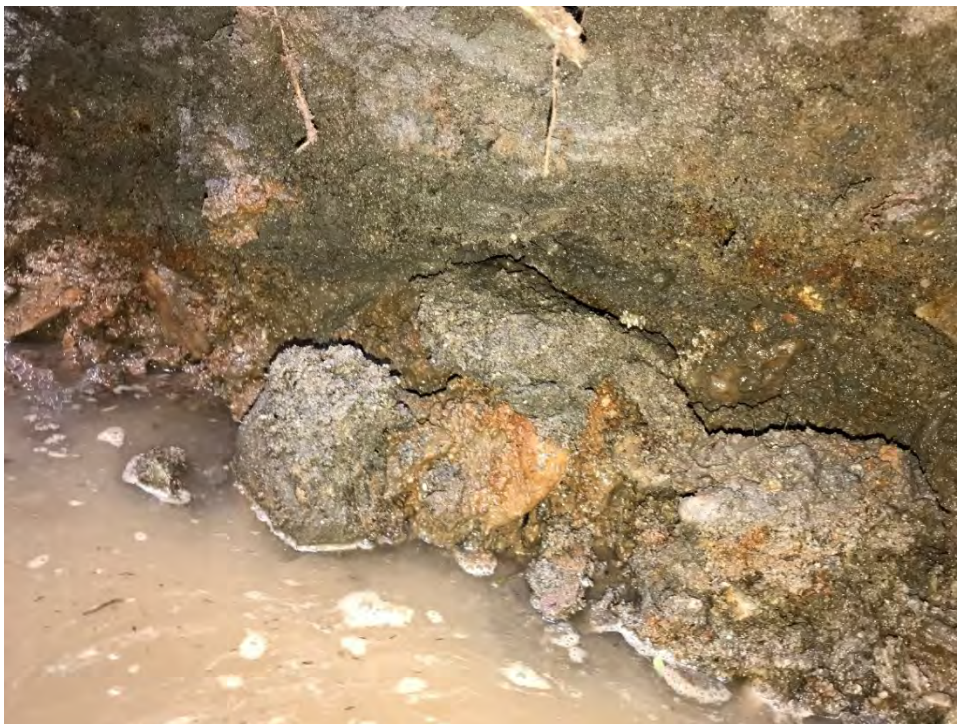
Figure 6: Trench along the main stem of the Jones Falls showing where layers of hydric soil and basal gravel were found

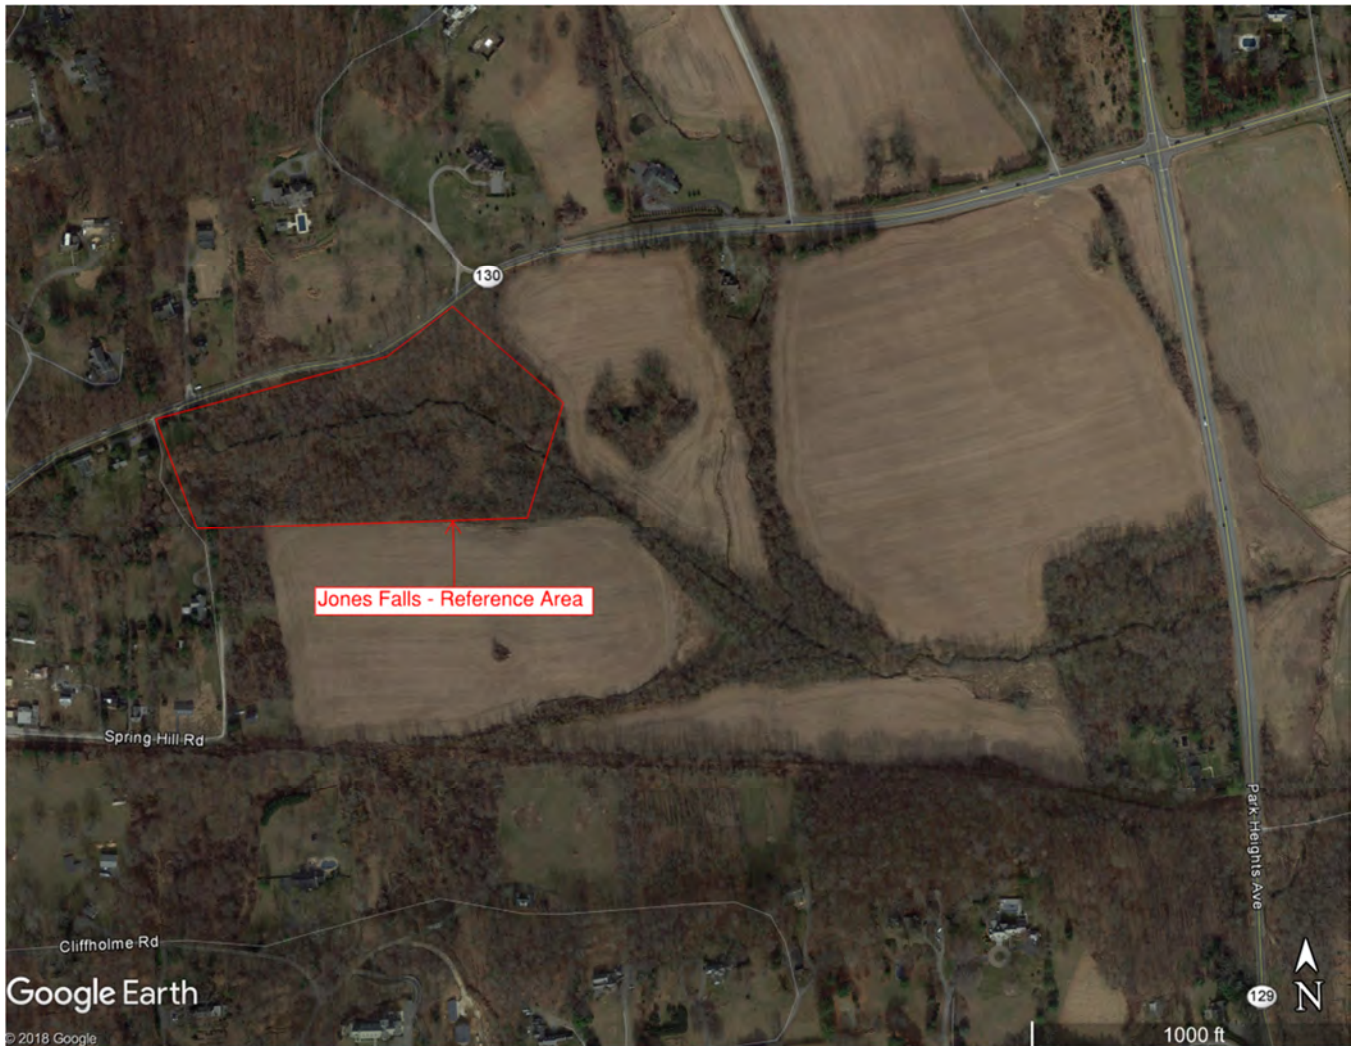
Figure 7: Key map of Jones Falls Reference Area

The upstream limits of the Jones Falls Reference Area (**Figure 7**) begins at the Spring Hill Road culvert and flows approximately 1,315 feet downstream along the main stem. This area of the project site includes an existing trout spawning area, a bald cypress wetland, and the location of two basal gravel sample areas, one point bar sample, two cross sections, and one longitudinal profile. An existing stone wall also exists directly upstream of the Middle Jones reach. Although some previous impacts are observed in this reach, such as damming and legacy sediment, drain tile, and similar disturbance, a dense native tree canopy is observed as well as connection to floodplain wetlands. Minor bank erosion

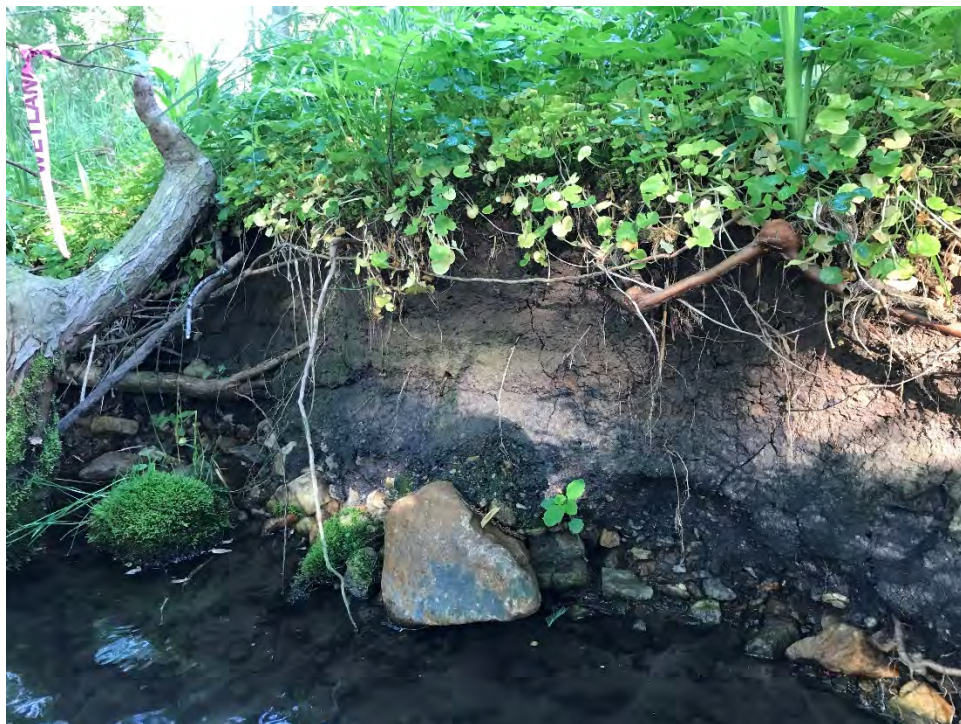
Figure 10: Basal gravel sample #5 (facing left bank)

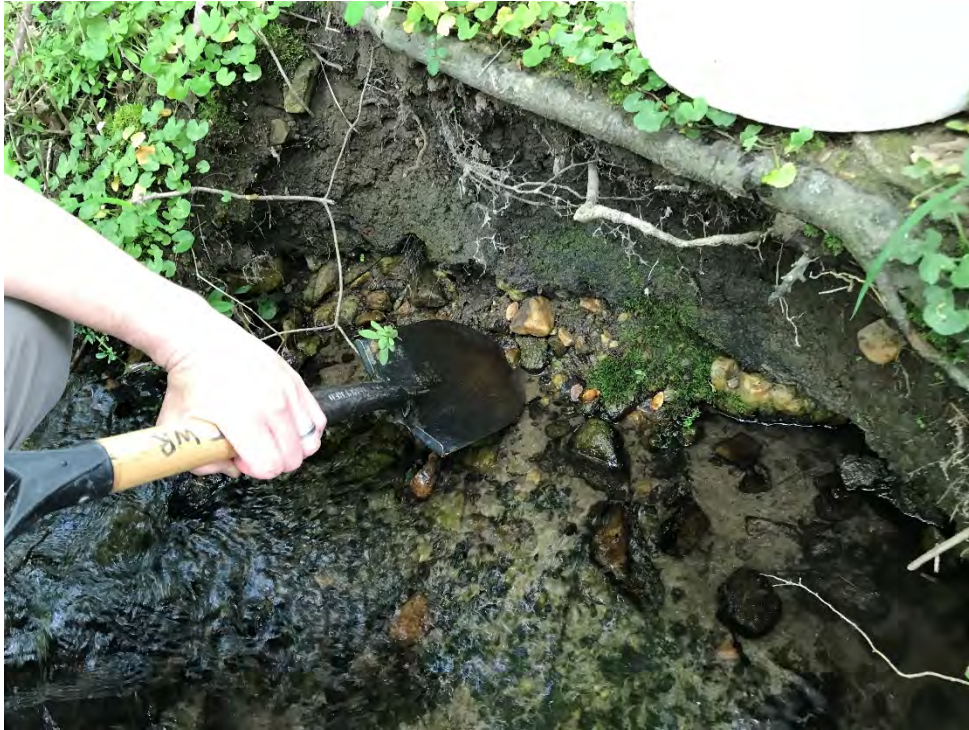
Figure 11: Basal gravel sample #4 (facing left bank)

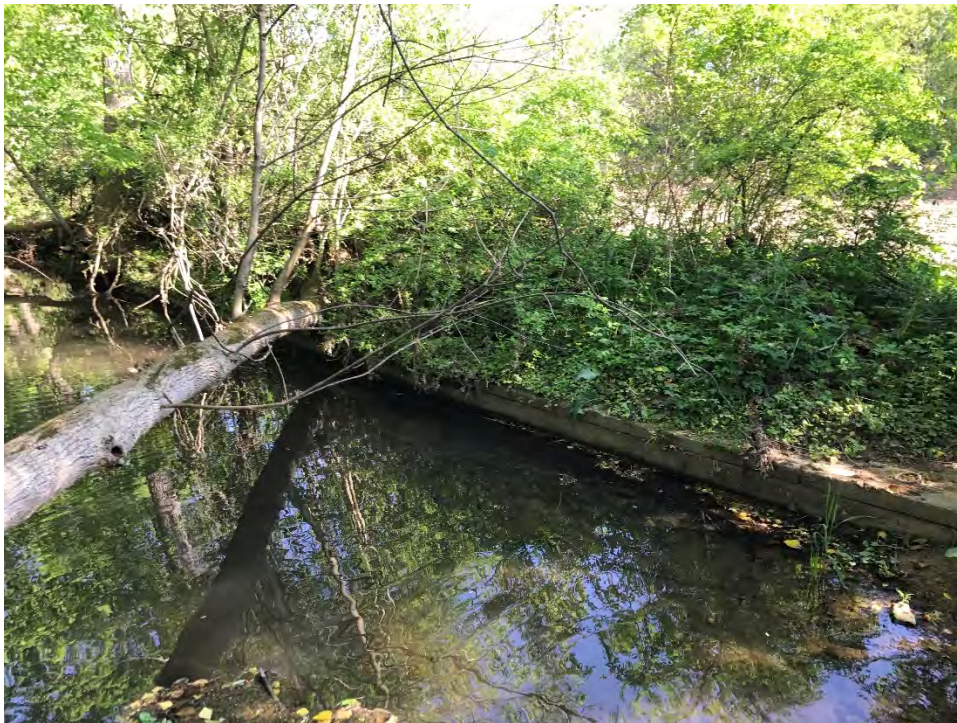
Figure 18: Concrete wall in channel upstream of concrete dam in Middle Jones

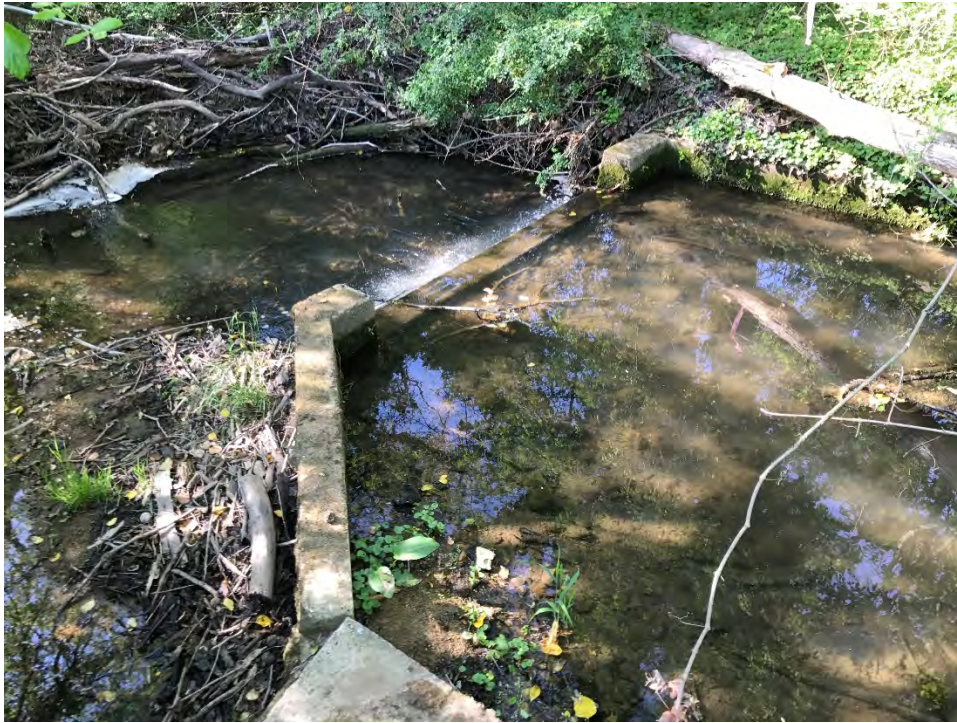
Figure 19: Concrete dam in Middle Jones

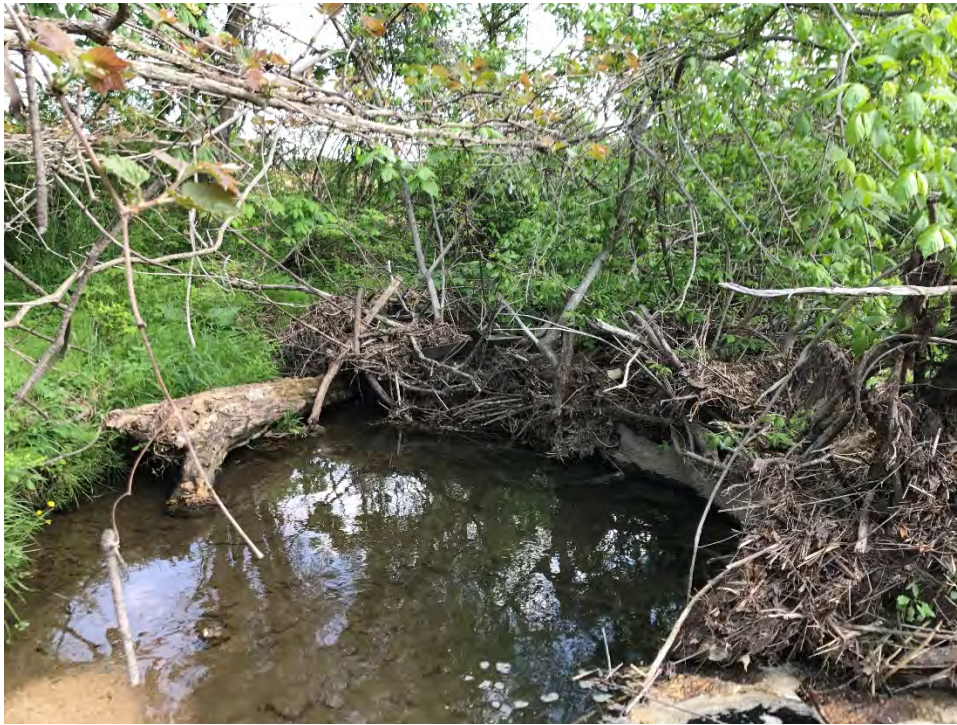
Figure 25: Debris jam at upstream end of Walnut-Horse Chestnut Reach

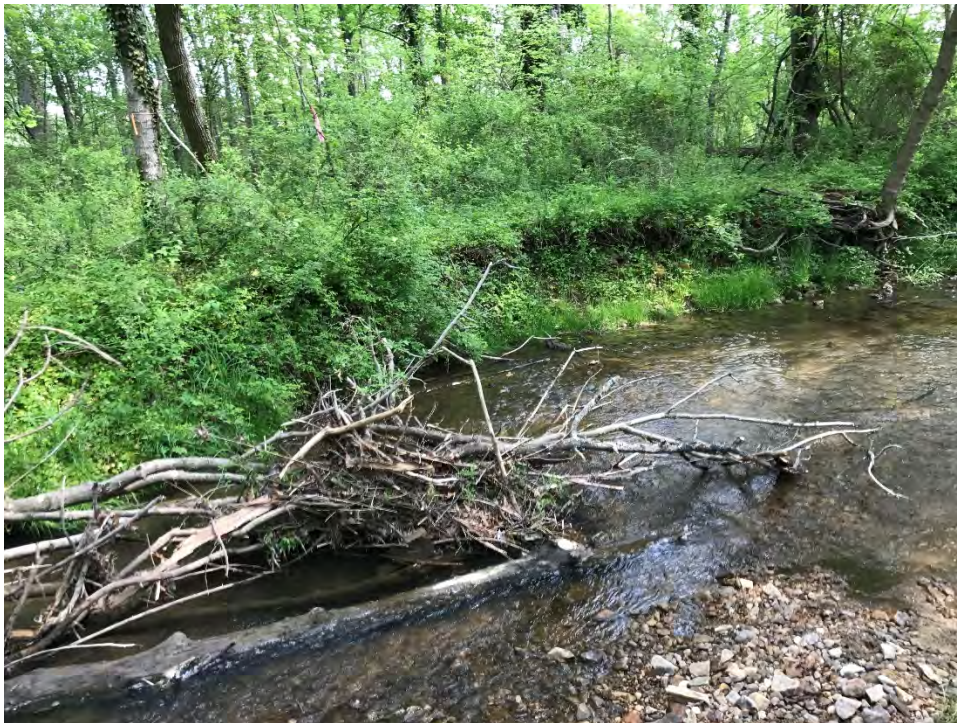
Figure 32: Debris jam within Downstream Forested Jones (upstream of trout spawning area)

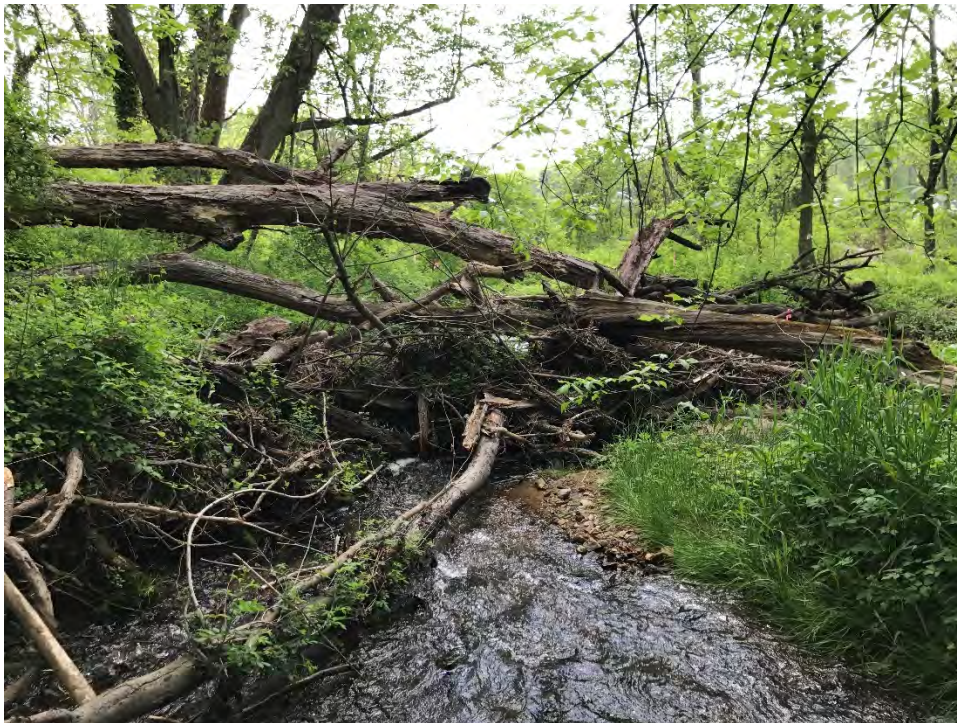
Figure 34: Debris jam at downstream end of Downstream Forested Jones (2018, now missing)

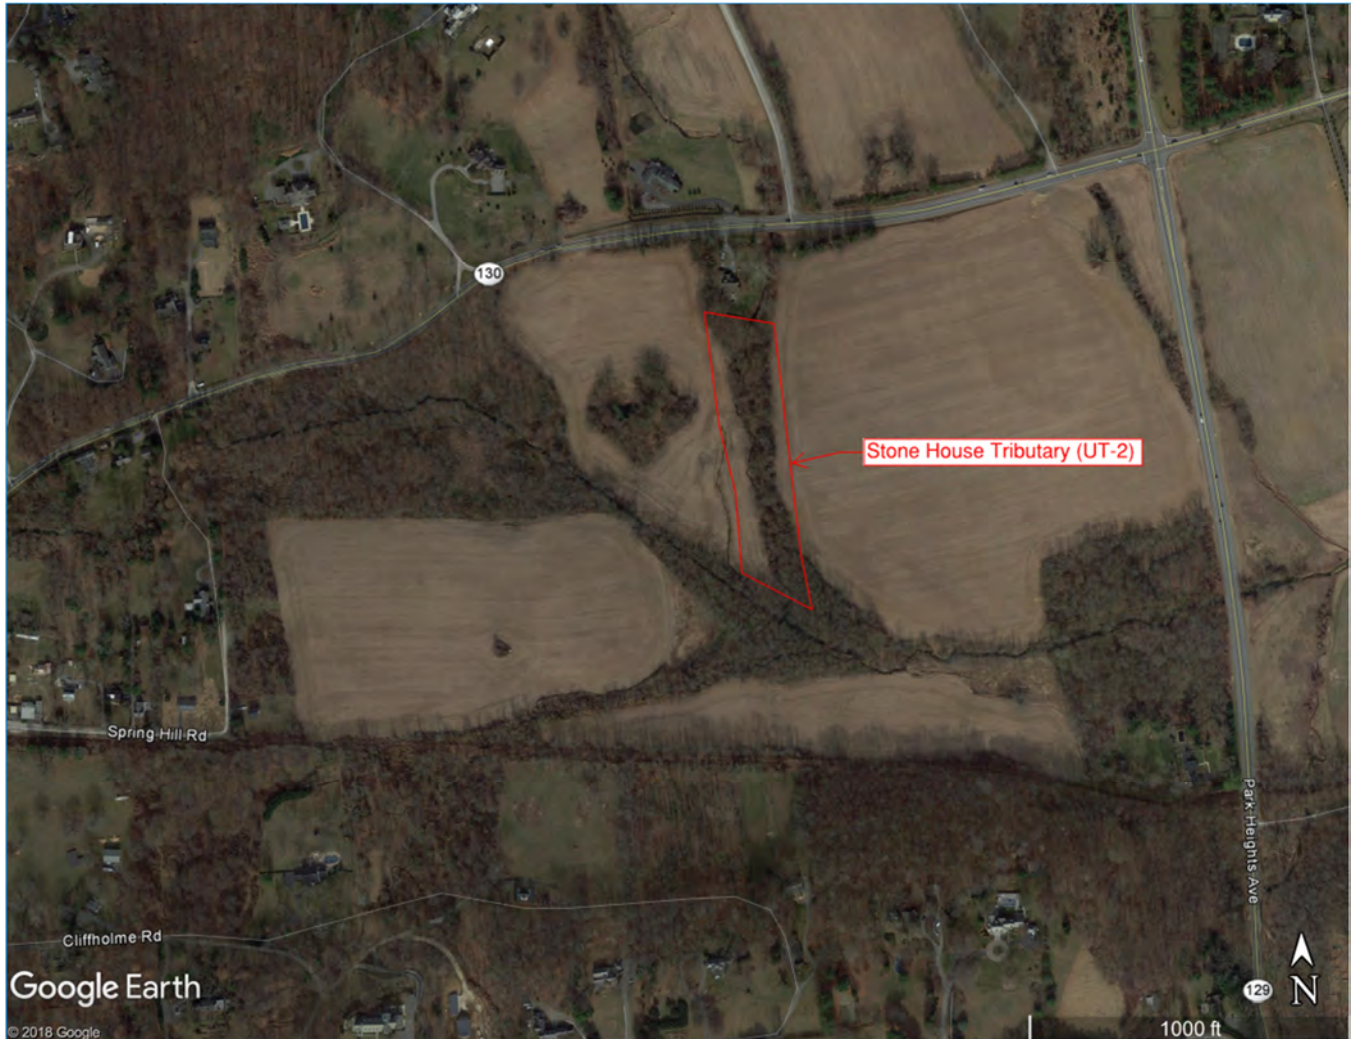
Figure 38: Key Map of North Tributary Reach

The North Tributary (Figure 38) begins at an existing 16-foot wide stone wall flowing north to south and tying into the Jones Falls at the downstream end of the Middle Jones portion of the main stem from the north side of the channel. The channel flows in and out of a forested area and is adjacent to a cultivated field that is located to the west of the channel. A drainpipe inflow exists within the active channel approximately 200 feet downstream from the stone wall; this pipe diverts all flow from the North Tributary into a separate channel to the west, leaving the rest of the North Tributary completely dry. The channel is periodically diverted; MDTA has observed the pipe inlet clogged with flow occurring in the original bed location, but for this assessment flow was not present. This diversion occurs irregularly due to the pipe being clogged with debris and is not predictable. The tributary downstream of the drainpipe inflow is completely dry and only conveys flow during storm events when diverted. The total length of the channel downstream of the drainpipe to the tie-in with Jones Falls is approximately 900 feet. One longitudinal profile and one cross section were also taken in this tributary.

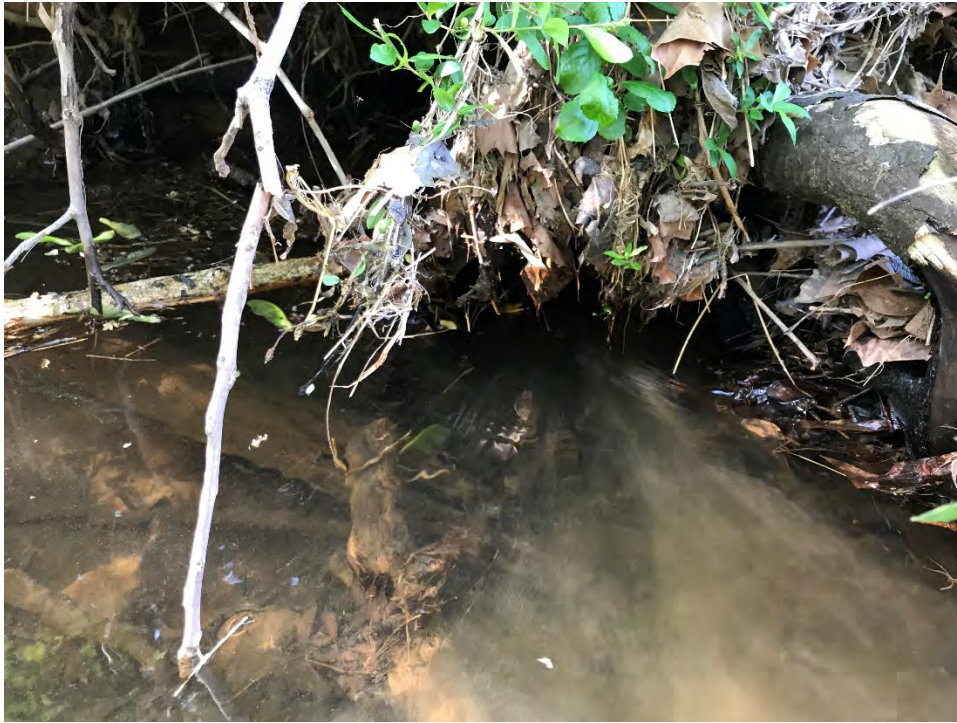
Figure 39: Drain pipe inflow located in active channel (facing right bank)

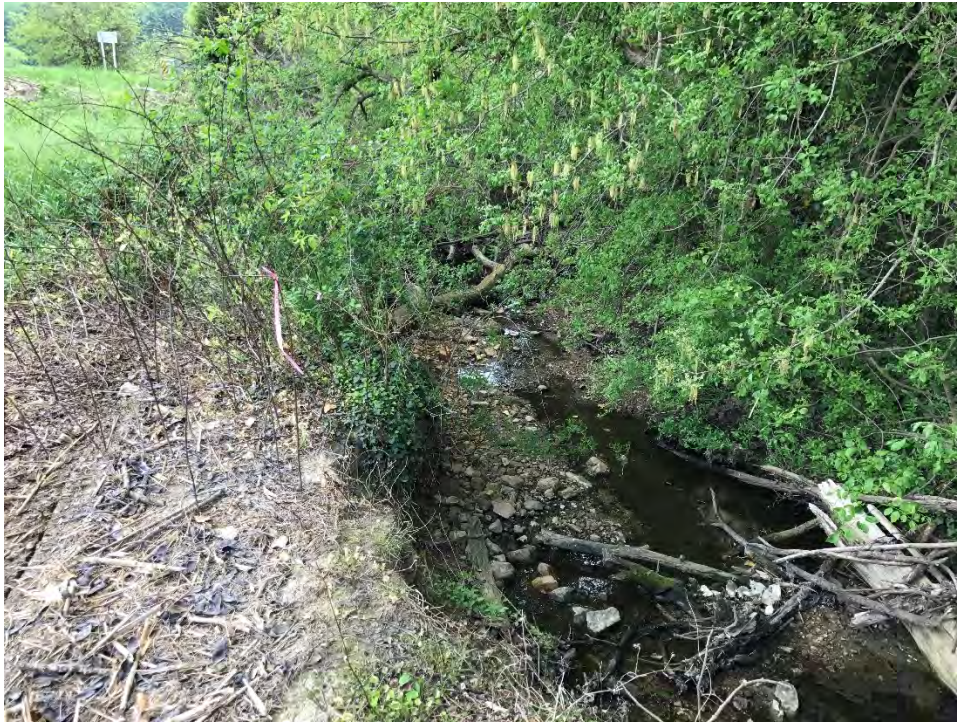
Figure 46: Channel erosion within Intersection Tributary

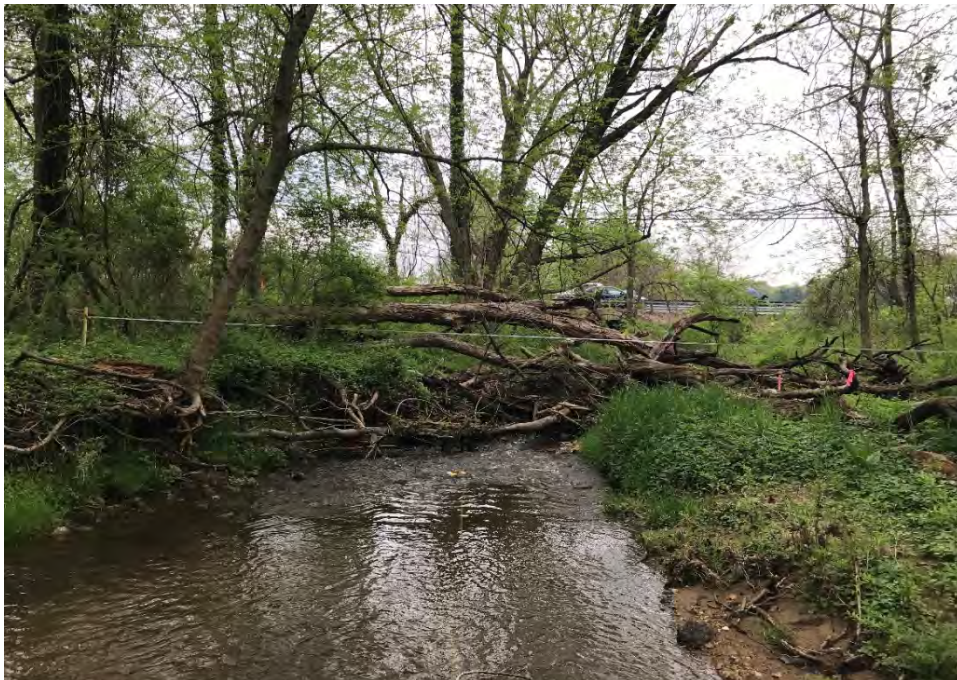
Figure 47: XS 1-1 riffle cross section looking downstream (Jones Falls)

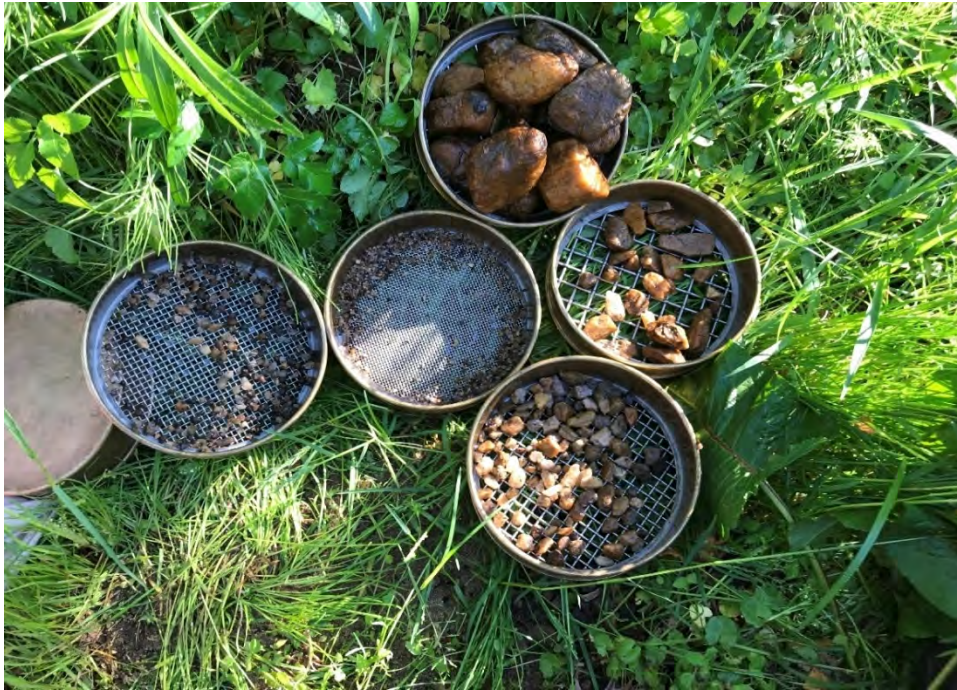
Figure 61: Portion of the basal gravel sample #2

Larger cobble and even small boulder quartzite particles were observed to be part of the historic substrate material where samples were collected. The largest particles observed within the system will likely provide an additional armoring component within the restored valley bottom (Figure 61).

Particle Size (mm)	Basal Gravel Sample #2	Basal Gravel Sample #4	Basal Gravel Sample #5
D35	14.77	6.80	29.71
D50	27.38	17.59	43.12
D84	56.97	46.27	72.28

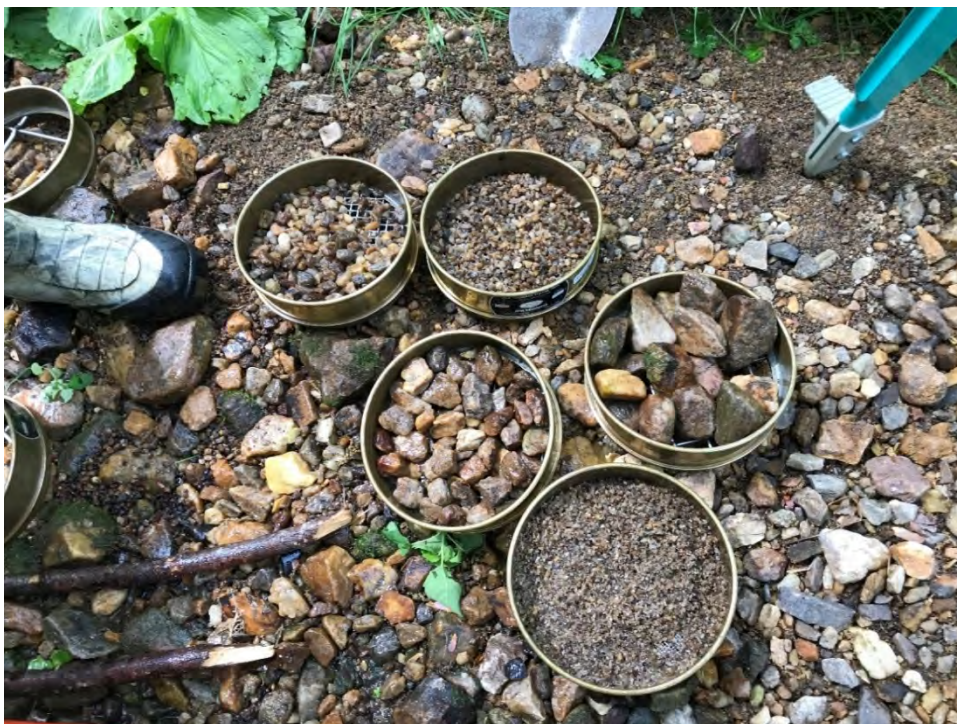
Figure 62: Portion of the basal gravel sample #4

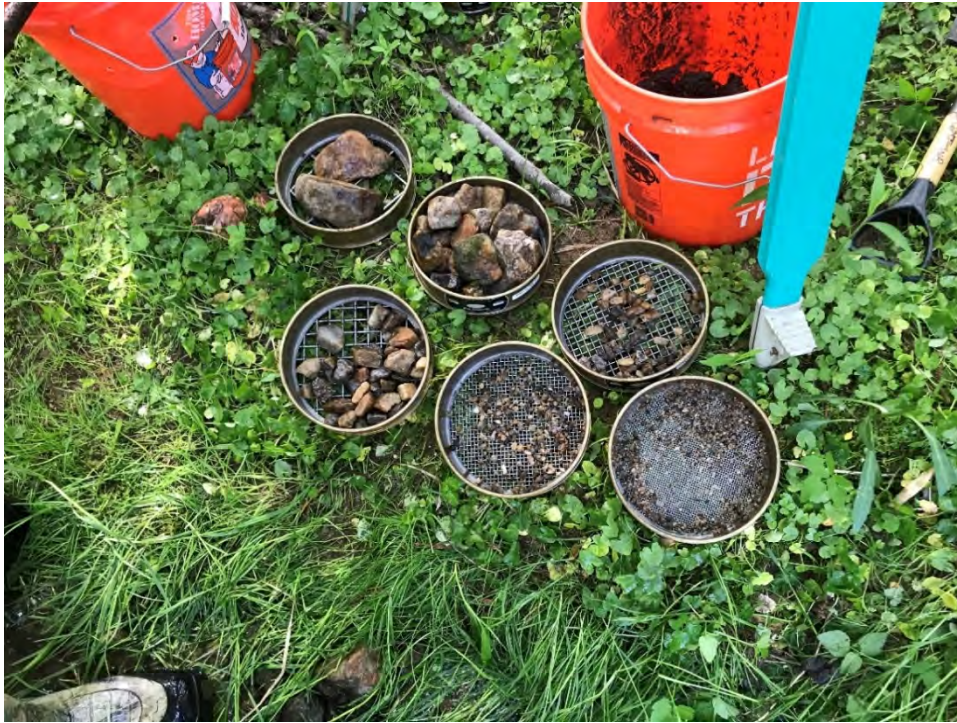
Figure 63: Portion of the basal gravel sample #5

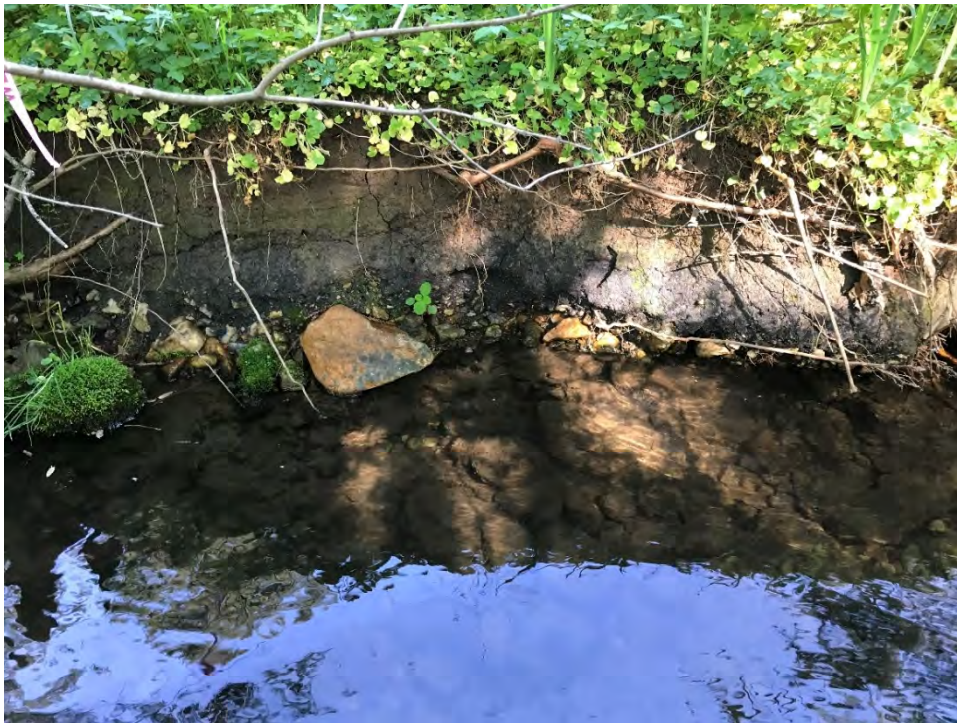
Figure 64: Larger particle found at basal gravel sample #5

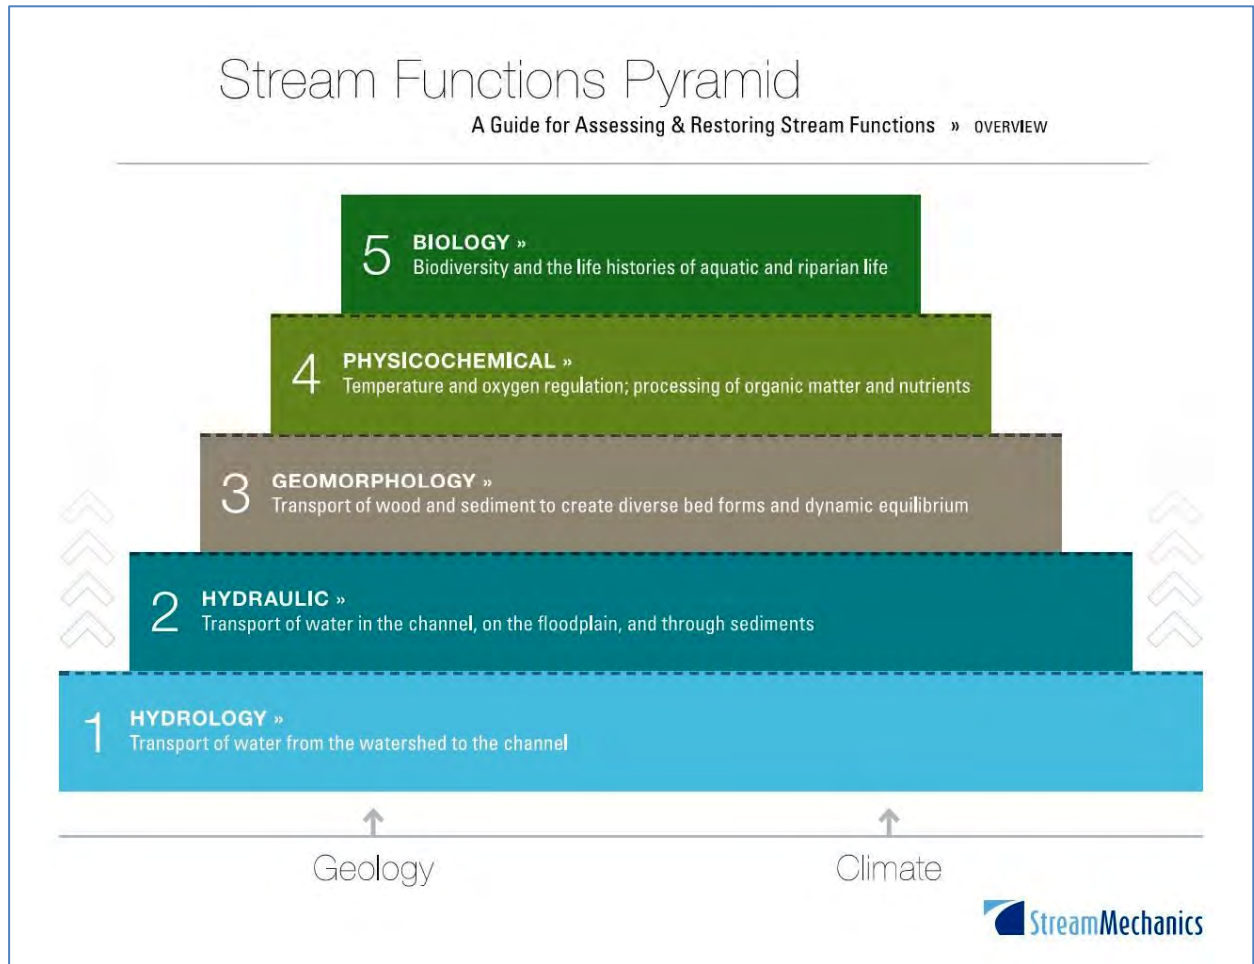
Figure 65: Stream Functions Pyramid (Harman et al., 2012)

developed by the U.S. Fish and Wildlife Service (Starr et al. 2015) and the ecological benefits or functional uplift they may provide. The assessment methodology is largely based on the Stream Functions Pyramid as described in *A Function-Based Framework for Stream Assessment and Restoration Projects* (Harman et al. 2012) (Figure 66). The pyramid consists of a hierarchal relationship of five (5) critical categories that evaluate the health and function of a stream.
