# Gantry/Camera Replacements

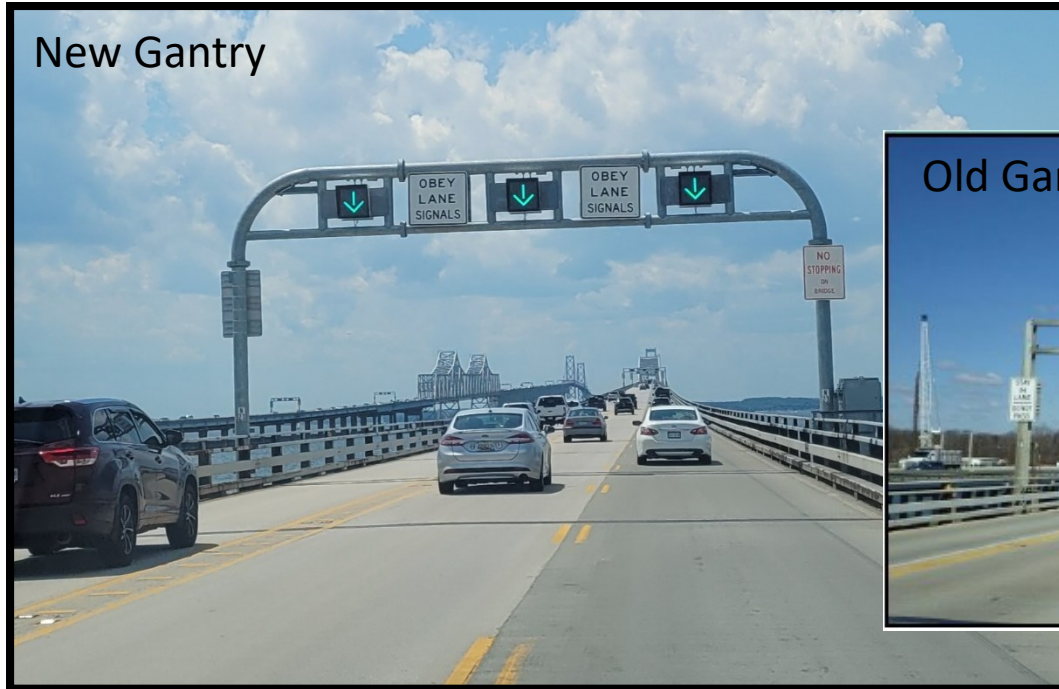
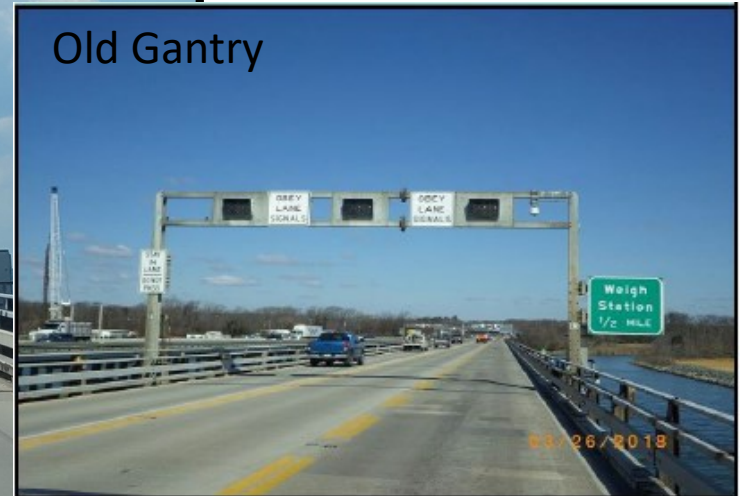
- Replacing 17 gantries on Westbound Bridge (BB-2819)
  - Condition inspection findings showed defects in the structures and the LED signals were at the end of their expected life cycle
  - Circular monotube gantry design is replacing square truss gantry
  - Replacing attachments – Lane Use Control Signals, Signs, and CCTV Cameras
